HI-FI HOME INSPECTIONS L.L.C

## BEN GROMICKO'S TEMPLATE FOR HOME INSPECTIONS

1234 Main Street  
Palo Alto, CA 94301

Buyer Name  
08/25/2025 9:00AM

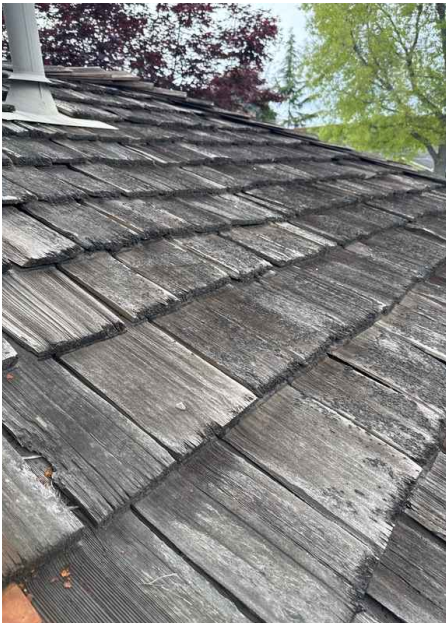
Roof Covering: Roof Was Inspected

Roof, Drone

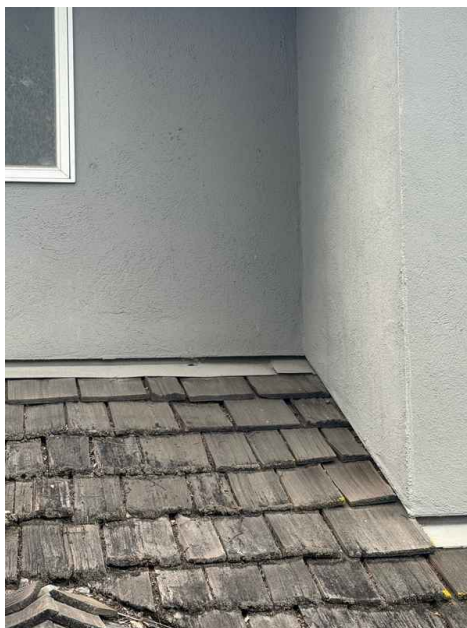
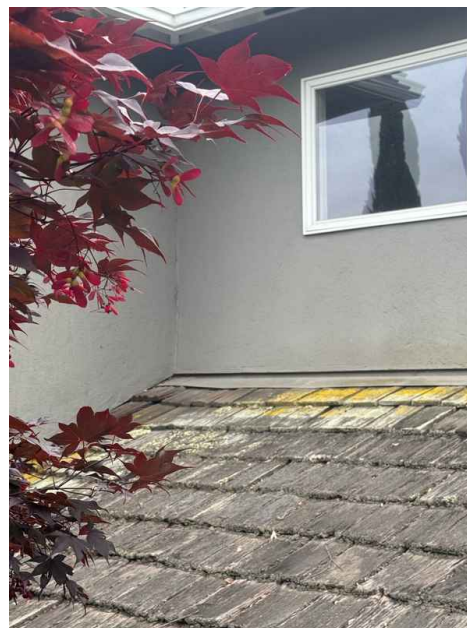
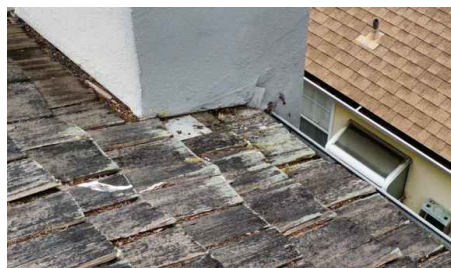
## Flashing: Wall Intersections

I looked for flashing where the roof covering meets a wall or siding material. There should be step and counter flashing installed in these locations. This is not an exhaustive inspection of all flashing areas.

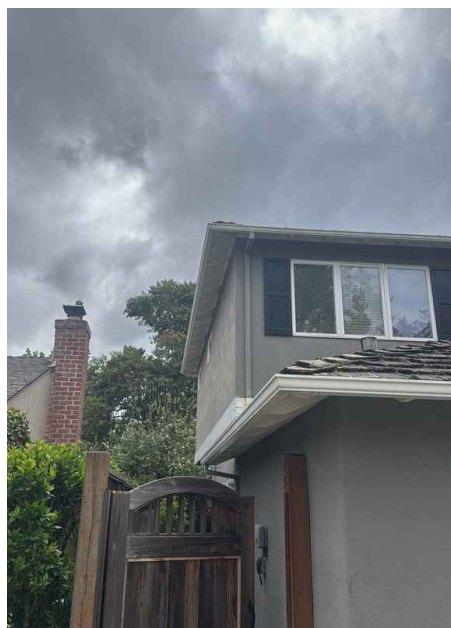
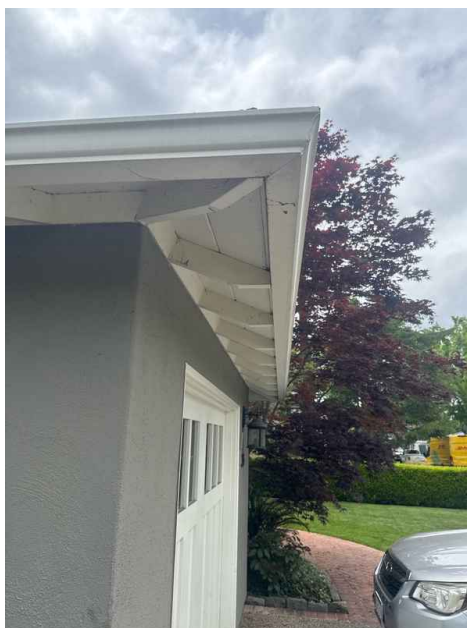
## Flashing: Eaves and Gables

I looked for flashing installed at the eaves (near the gutter edge) and at the gables (the diagonal edge of the roof). There should be metal drip flashing material installed in these locations. The flashing helps the surface water on the roof to discharge into the gutter. Flashing also helps to prevent water intrusion under the roof-covering.

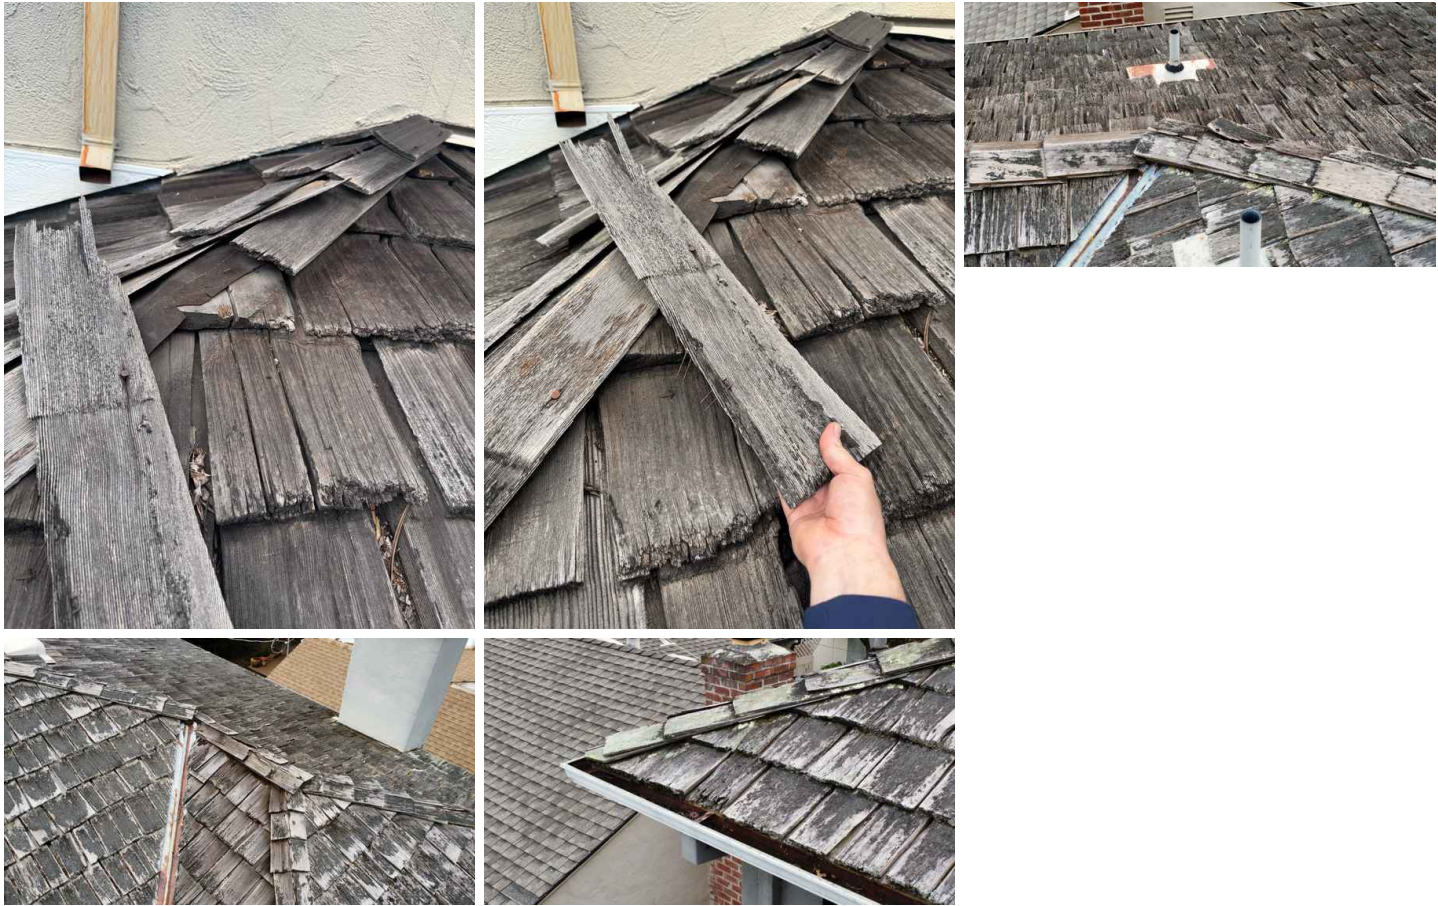
### CRACKED ROOF-COVERING MATERIAL

Major Defect

I observed cracked and damaged shingles. Prone to leaking. Correction and further evaluation by a professional roofer is recommended.

Contact a qualified roofing professional.

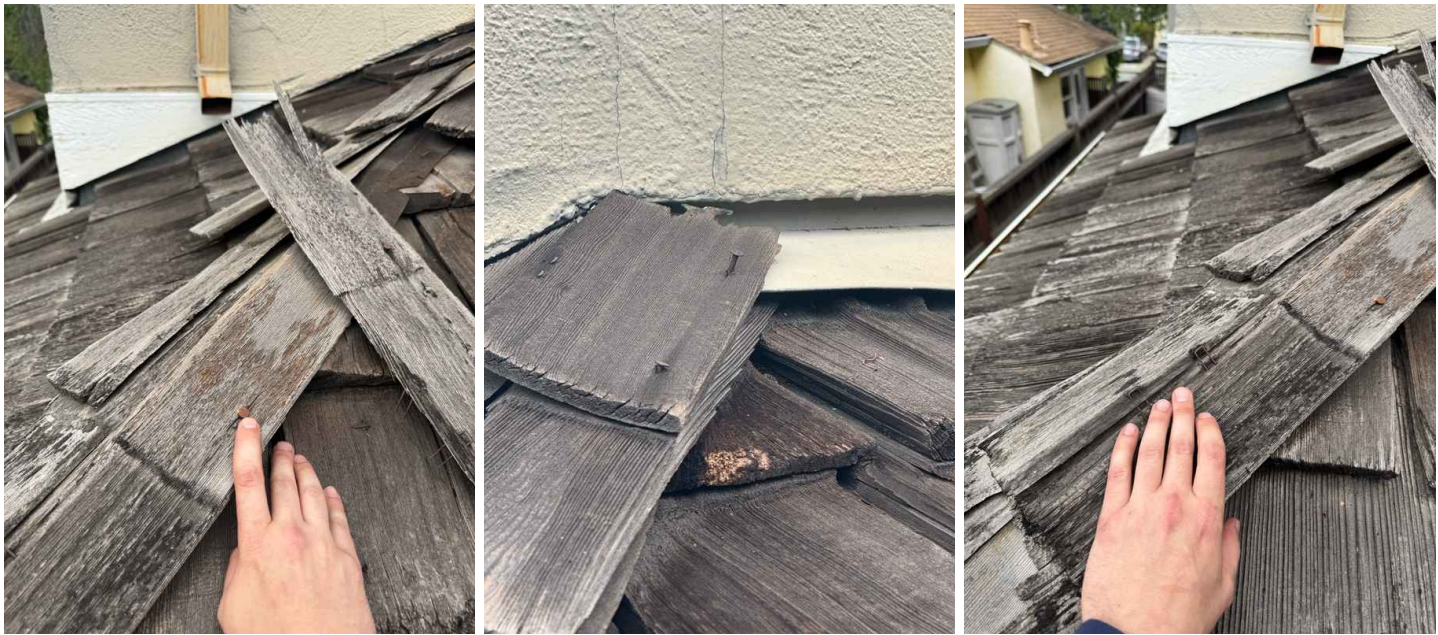
2.1.2 Roof Covering

**EXPOSED FASTENERS**

Major Defect

I observed indications of exposed fasteners at the roof-covering materials. Fasteners should not be exposed. Potential water entry points. Roof could leak. Further evaluation and correction is recommended.

Contact a qualified roofing professional.

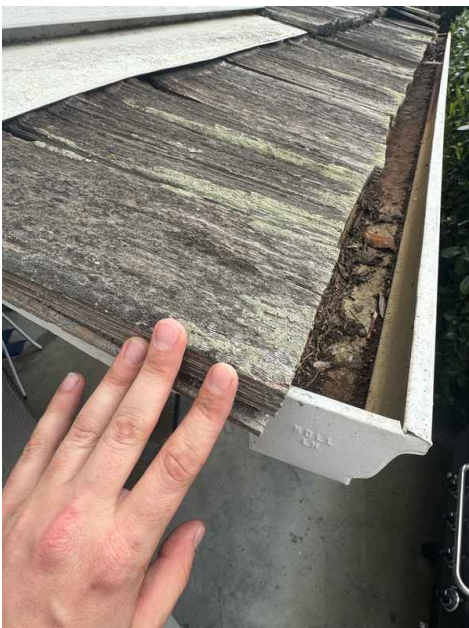
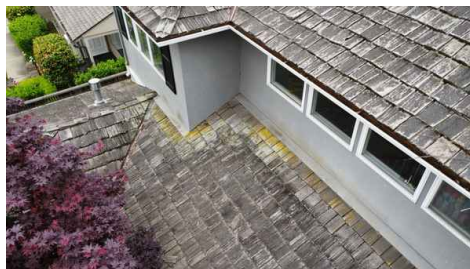
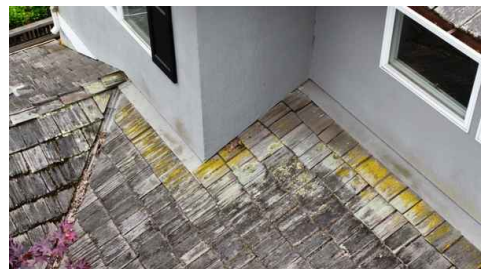
### 2.1.3 Roof Covering

#### **DISCOLORATION STAIN FROM ALGAE**

I observed indications of staining and discoloration on the roof-covering materials. This condition seemed to be caused from algae. What we commonly call algae is actually not algae, but a type of bacteria capable of photosynthesis. Algae appears as dark streaks, which are actually the dark sheaths produced by the organisms to protect themselves from UV radiation. When environmental conditions are right, the problem can spread quickly across a roof.

Algae attaches itself to the shingle by secreting a substance that bonds it tightly to the surface. Growth can be difficult to remove without damaging the roof. The best method is prevention. Algae stains can sometimes be lightened in color by using special cleaners.

Power-washing and heavy scrubbing may loosen or dislodge granules. Chemicals used for cleaning shingles may damage landscaping. Also, the cleaning process makes the roof wet and slippery, so such work should be performed by a qualified professional.

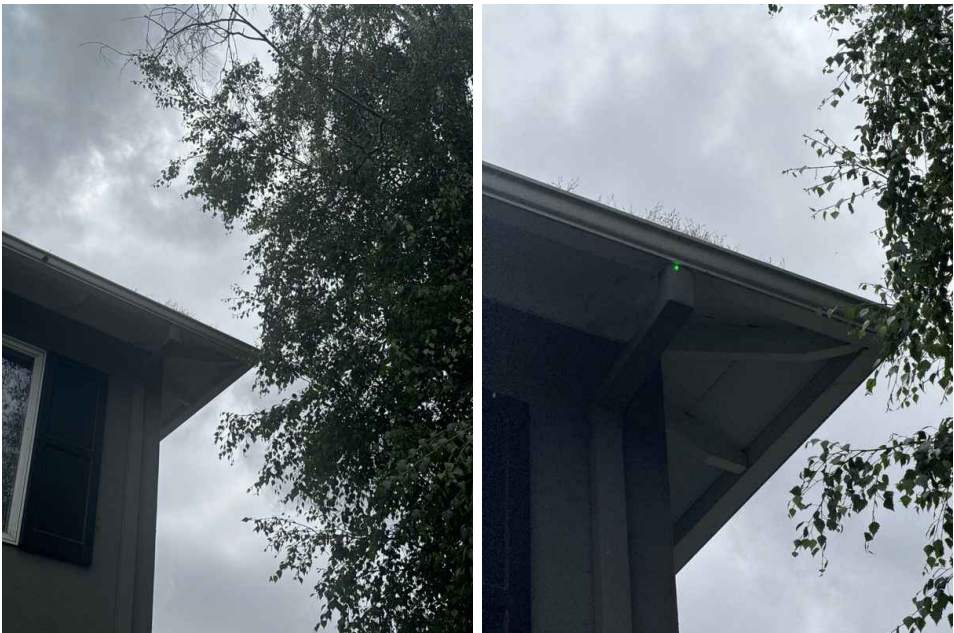
2.1.4 Roof Covering

**TREE TOO CLOSE**

Minor Defect

I observed indications that a tree and or tree branch where overhanging the roof and maybe in contact with it.

Contact a qualified tree service company.

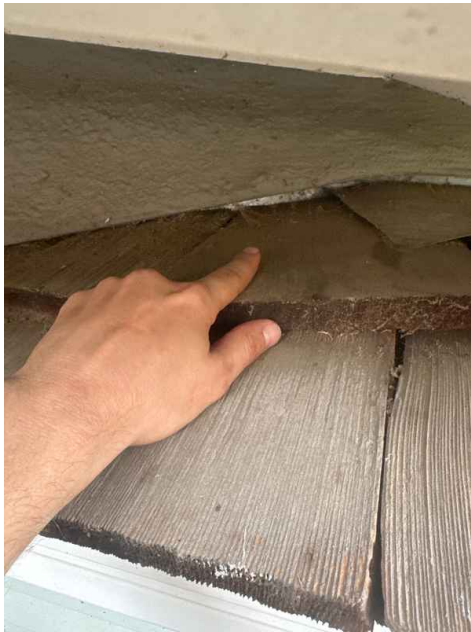
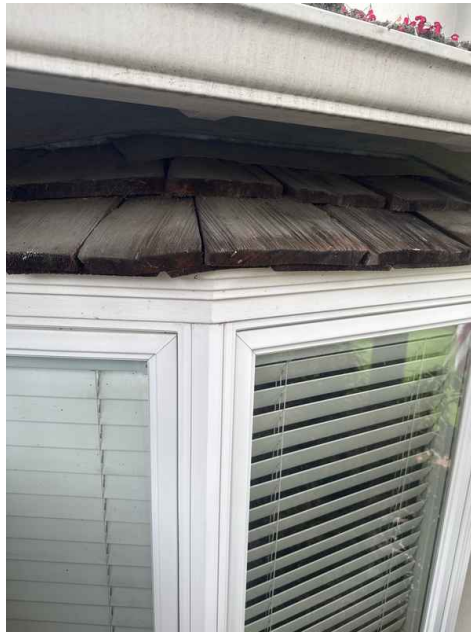
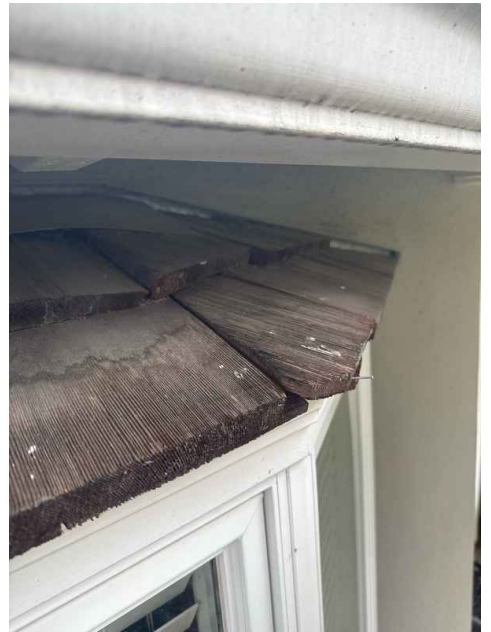
**MISSING FLASHING**

Major Defect

I observed areas where flashing was missing. Not installed. Improper installation of flashing. These areas of missing flashing are prone to water penetration. Flashing is installed to provide protection against roof leaks and to divert water away from certain areas. Correction and further evaluation is recommended.

Contact a qualified roofing professional.

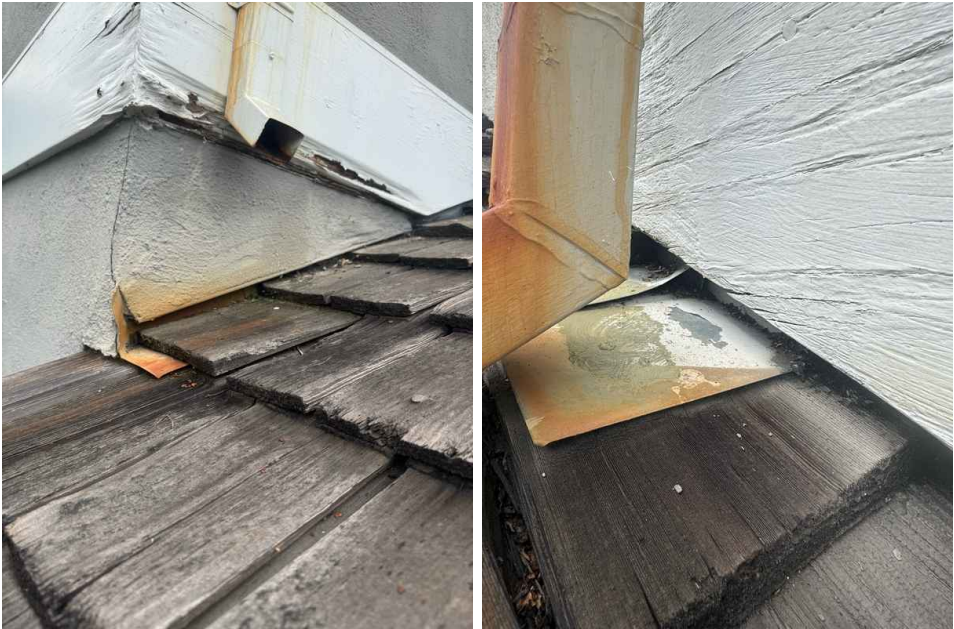
## 2.2.2 Flashing

**CORRODED - MINOR**

Major Defect

Roof flashing showed signs of corrosion, but seemed to not be a major defect. Flashing should be monitored to prevent severe corrosion leading to moisture intrusion.

Contact a qualified roofing professional.

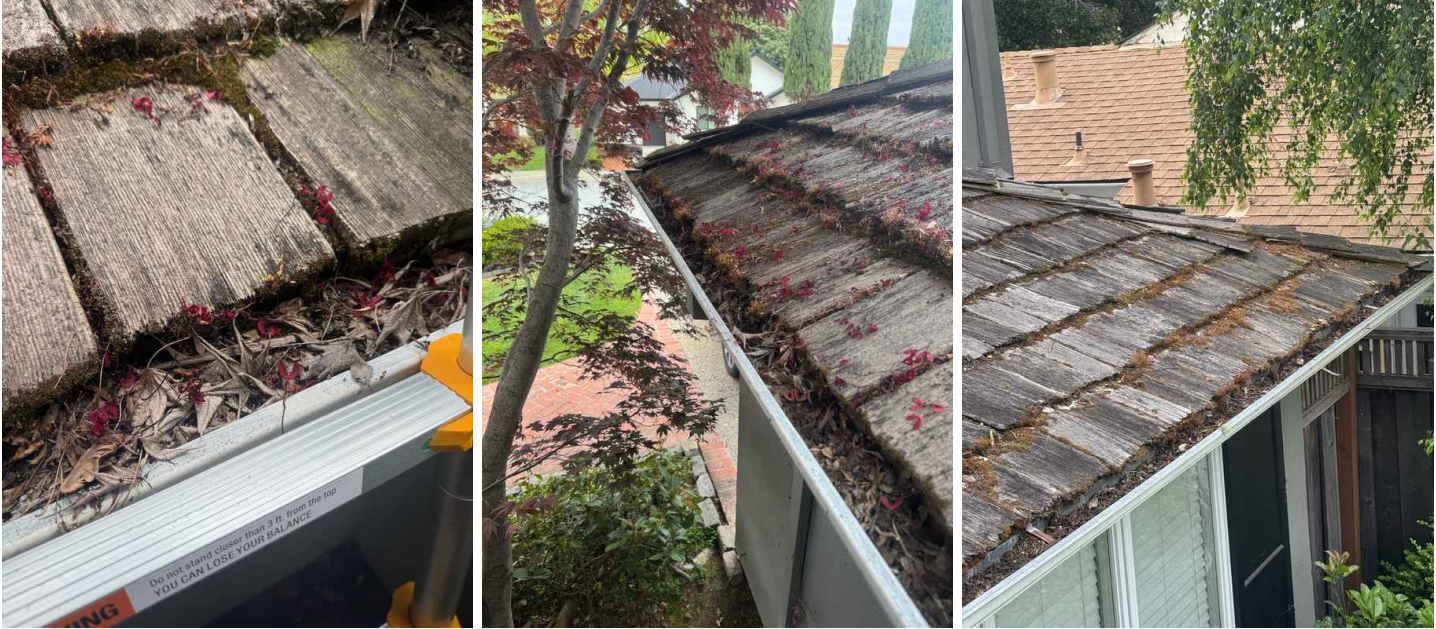
2.3.1 Gutters & Downspouts

**DEBRIS IN GUTTERS**

Minor Defect

I observed debris in the gutter. Cleaning and maintenance is recommended.

Contact a qualified gutter contractor

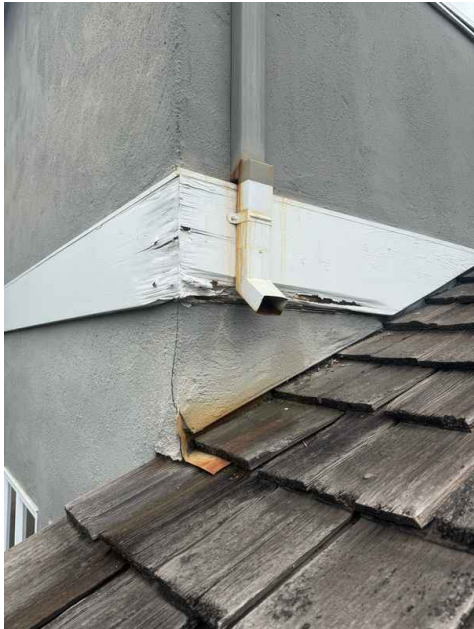
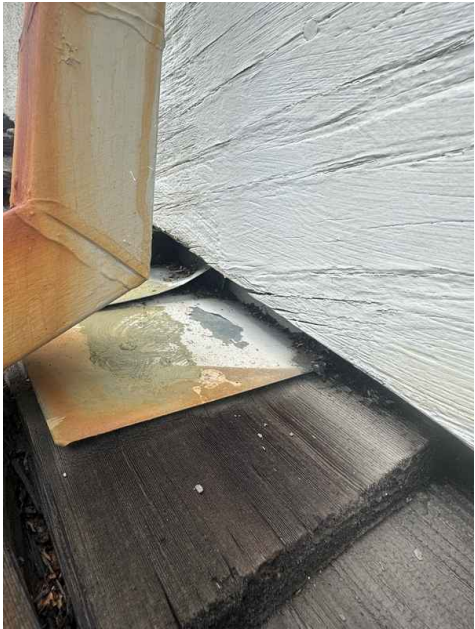
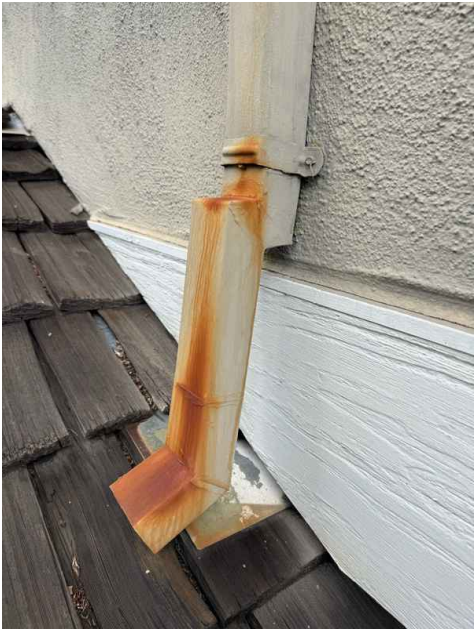
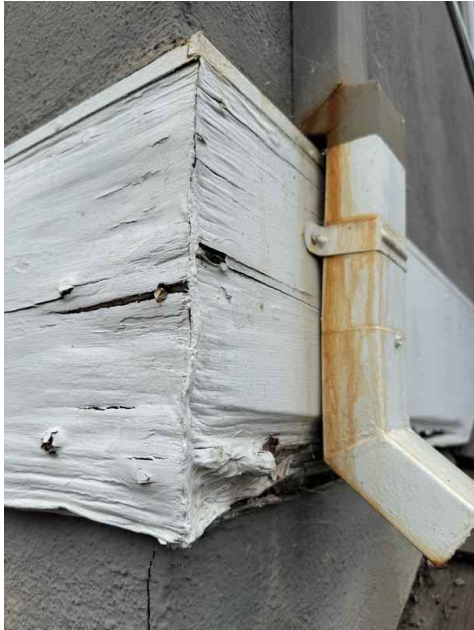
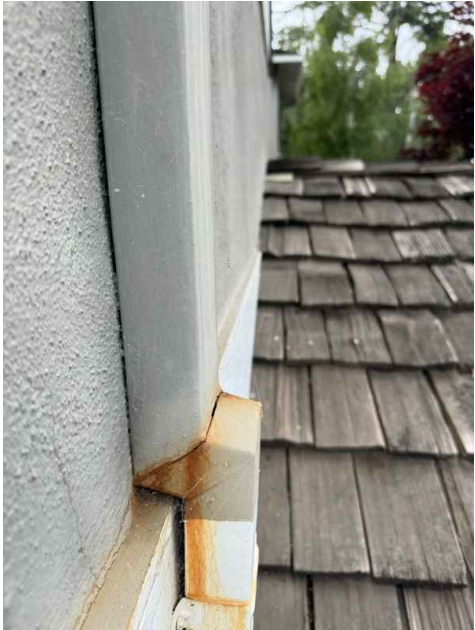
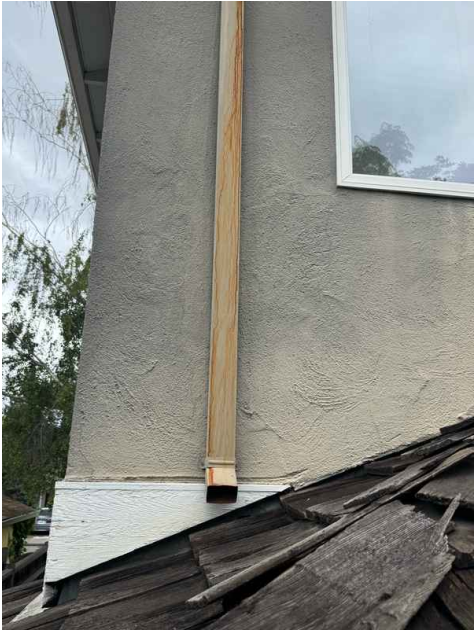
**GUTTER LEAKAGE**

Major Defect

I observed a water leak from a gutter, which could result in water not being properly collected and drained away. This is a defect that should be corrected by a professional contractor.

Contact a qualified gutter contractor

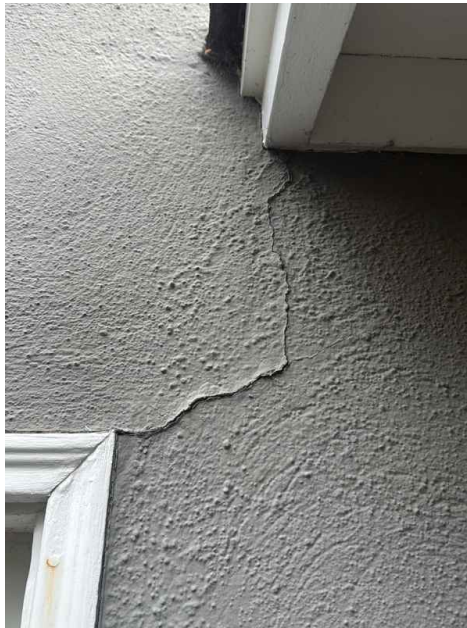
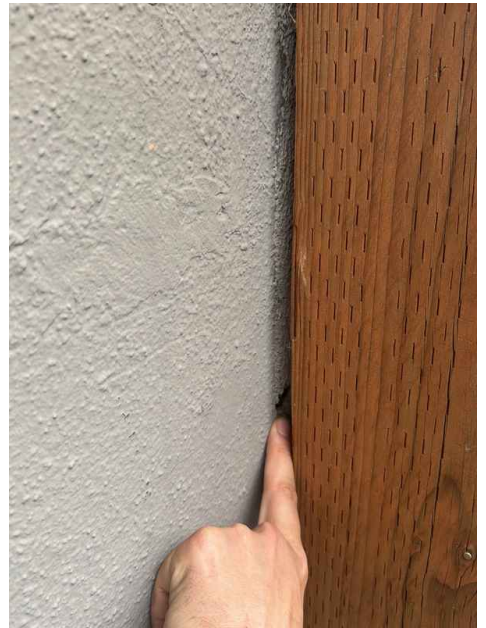
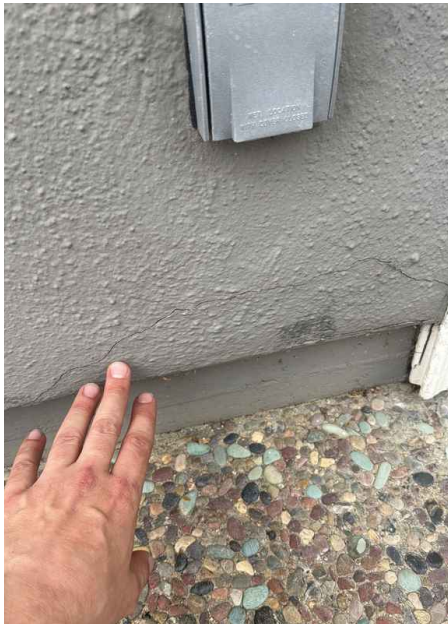
**Wall-Covering, Flashing & Trim: Worn Out Areas of Exterior Wall-Covering**

I observed indications of worn out areas, delayed maintenance, or aging.

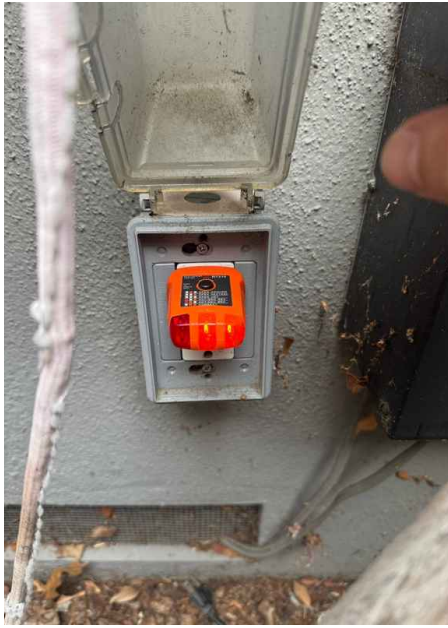
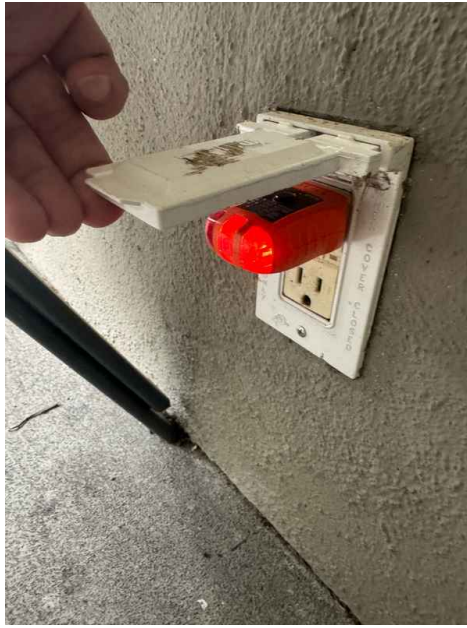
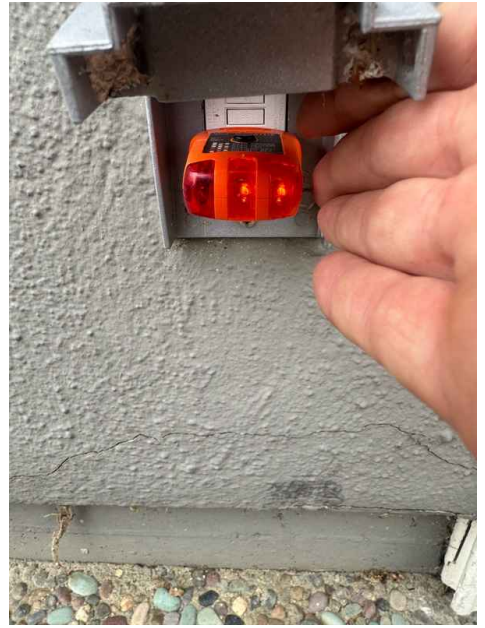
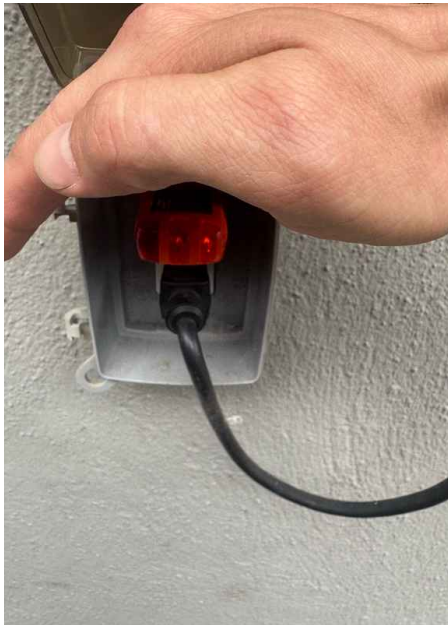
Walkways & Driveways: Walkways & Driveways Were Inspected

I inspected the walkways and driveways that were adjacent to the house. The walkways, driveways, and parking areas that were far away from the house foundation were not inspected.

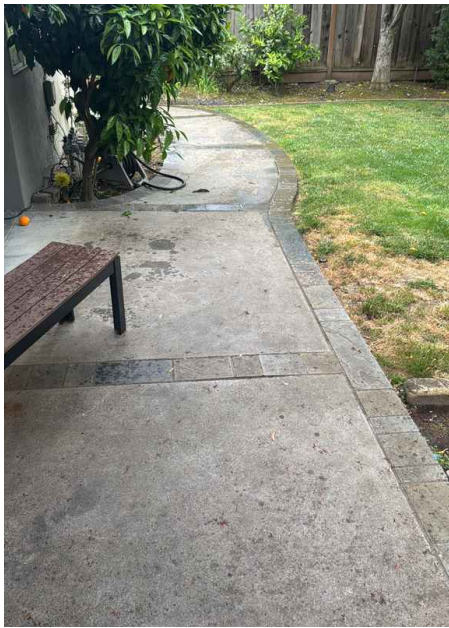
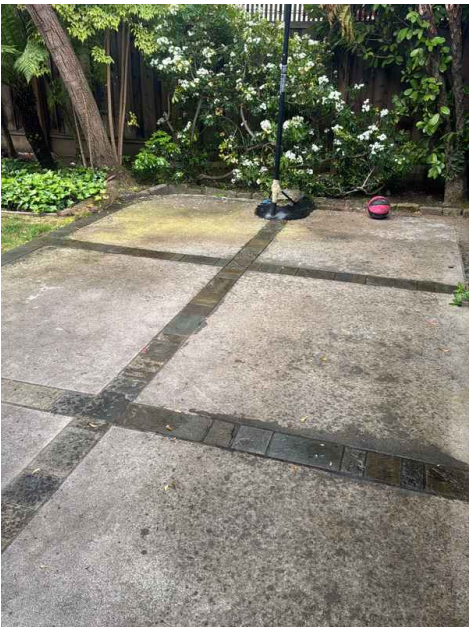
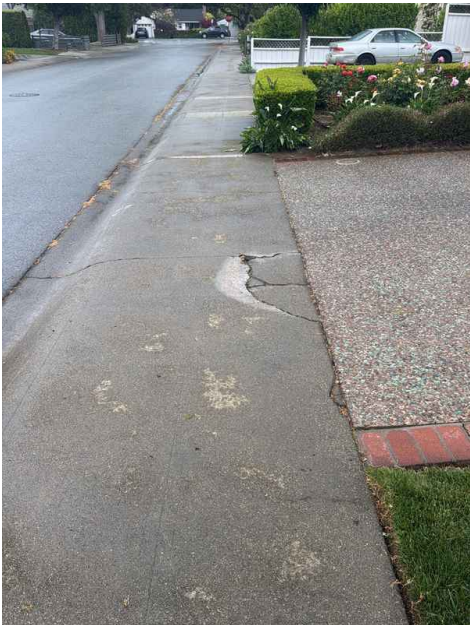
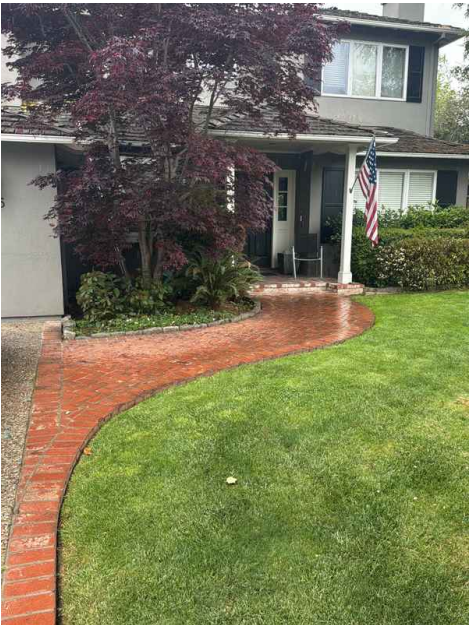
**Stairs, Steps, Stoops, Stairways & Ramps: Stairs, Steps, Stoops, Stairways & Ramps Were Inspected**

I inspected the stairs, steps, stoops, stairways and ramps that were within the scope of my home inspection.

All treads should be level and secure. Riser heights and tread depths should be as uniform as possible. As a guide, stairs must have a maximum riser of 7-3/4 inches and a minimum tread of 10 inches.

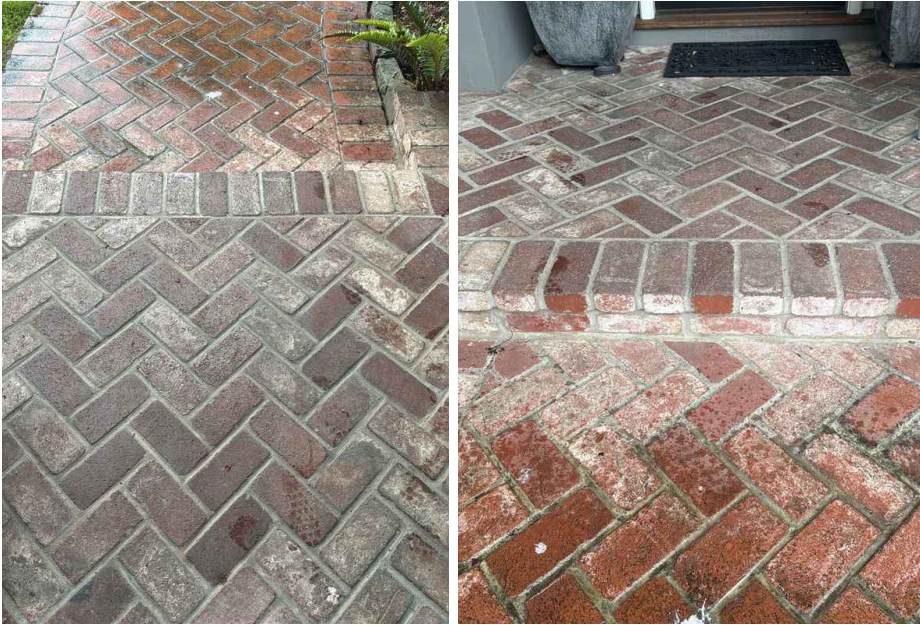
**Porches, Patios, Decks, Balconies & Carports: Porches, Patios, Decks, Balconies & Carports Were Inspected**

I inspected the porches, patios, decks, balconies and carports at the house that were within the scope of the home inspection.

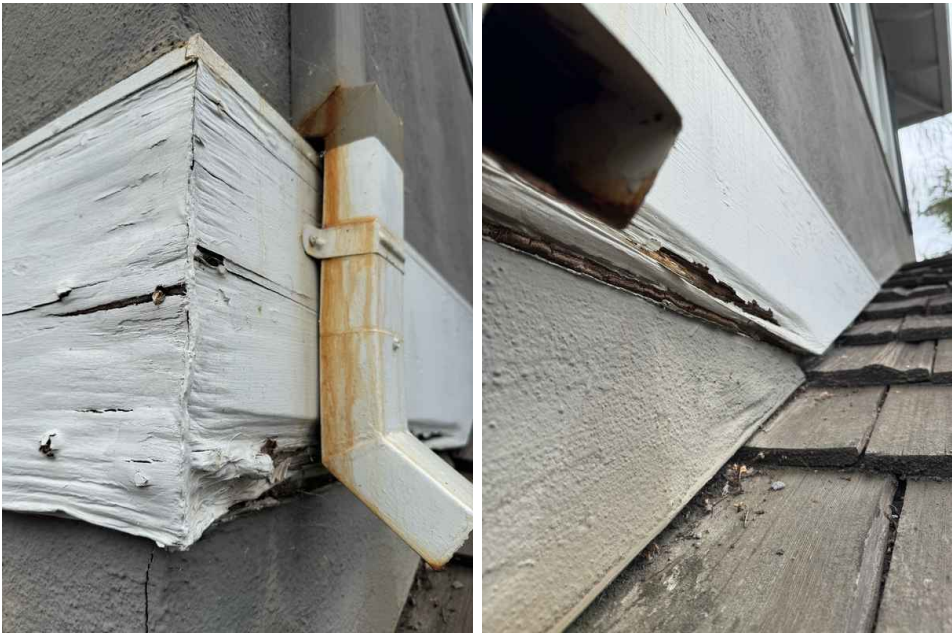
DAMAGE OBSERVED AT FASCIA

Major Defect

I observed indications that one or more areas of the fascia were damaged. Correction and further evaluation is recommended.

Contact a qualified general contractor.

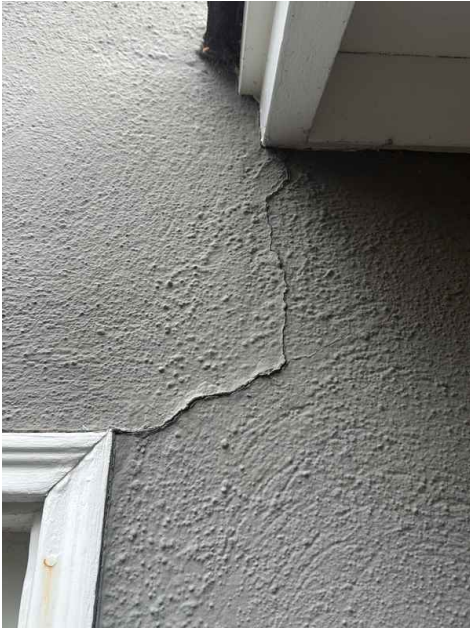
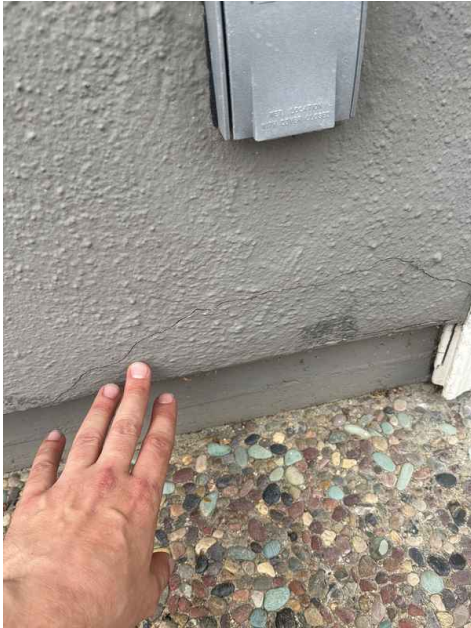
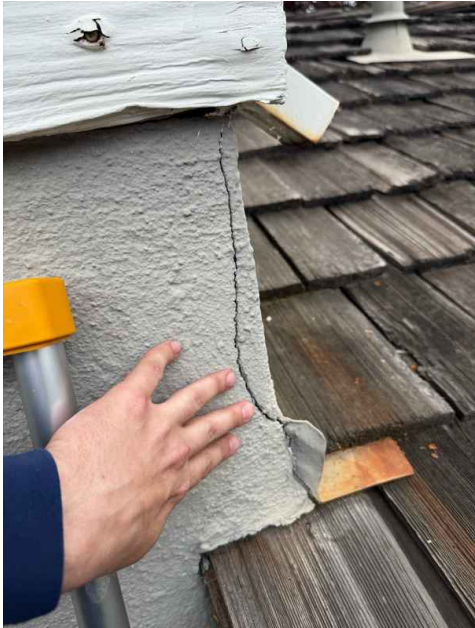
**CRACKING - MINOR**

Siding showed cracking in one or more places. Recommend monitoring.

Minor Defect

Recommendation  
Recommended DIY Project

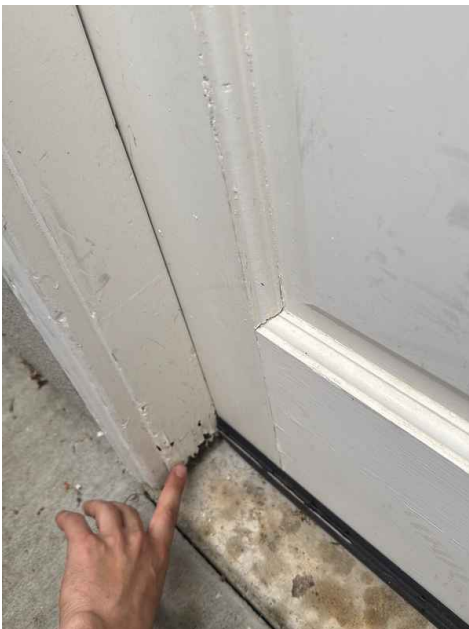
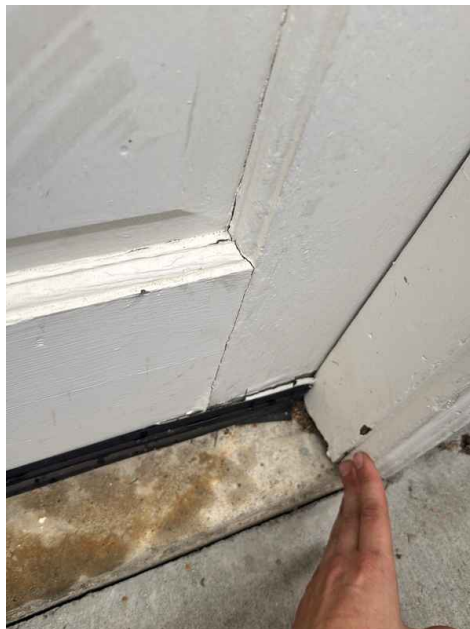
## 3.11.2 Exterior Doors

**EXTERIOR DOOR SURFACE IN POOR CONDIIION**

I observed that the surface of the exterior door was in poor condition.

Correction and further evaluation is recommended.

Minor Defect

Recommendation  
Contact a handyman or DIY project

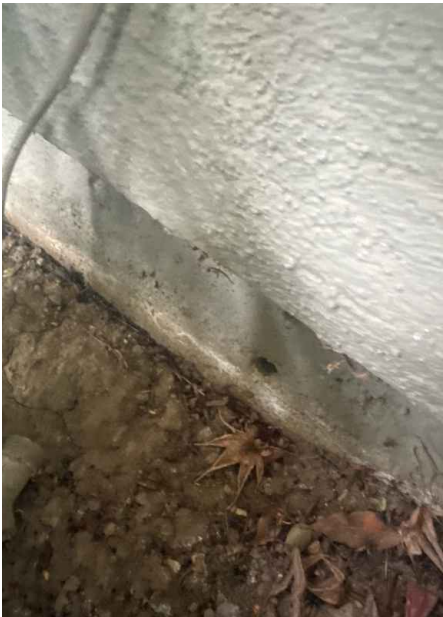
**Basement: Type of Basement Foundation Described**  
Concrete

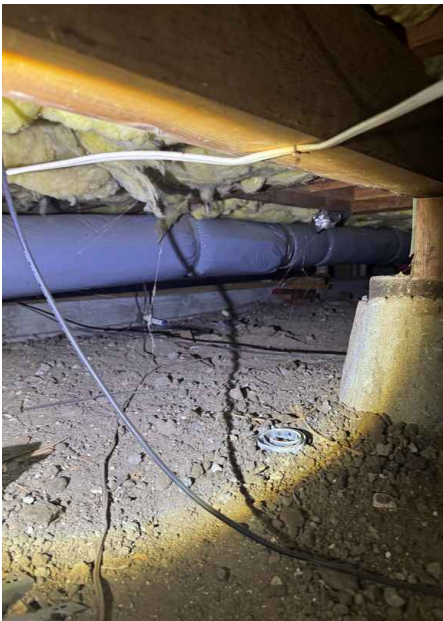
**Under-Floor Crawlspace: Type of Under-Floor Crawlspace Foundation Described**  
Dirt

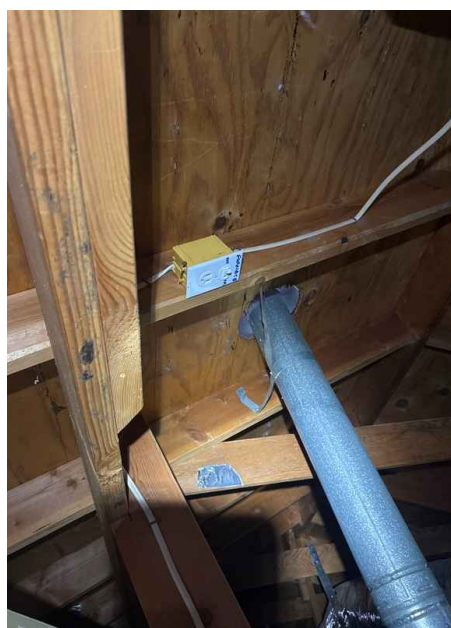
**Thermostat and Normal Operating Controls: Service Switch Inspected**

I observed a service switch. I inspected it. It worked when I used it during my inspection.

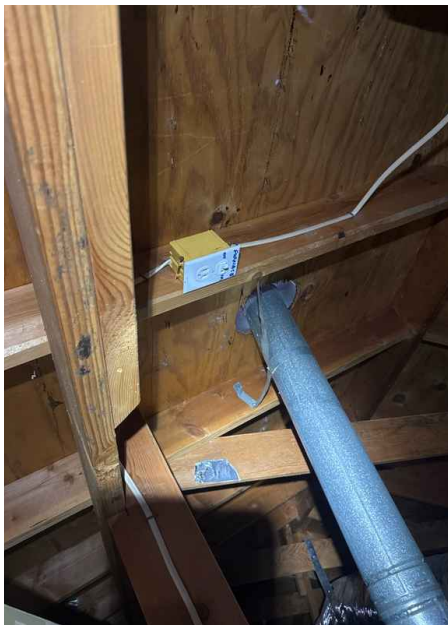
## Thermostat and Normal Operating Controls: Service Switch Inspected

I observed a service switch. I inspected it. It worked when I used it during my inspection.

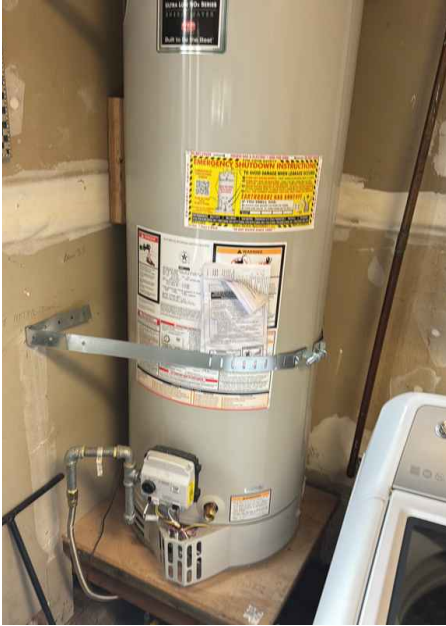
### Gas-Fired Hot Water Tank

I inspected for the main source of the distributed hot water to the plumbing fixtures (sinks, tubs, showers). I recommend asking the homeowner for details about the hot water equipment and past performance.

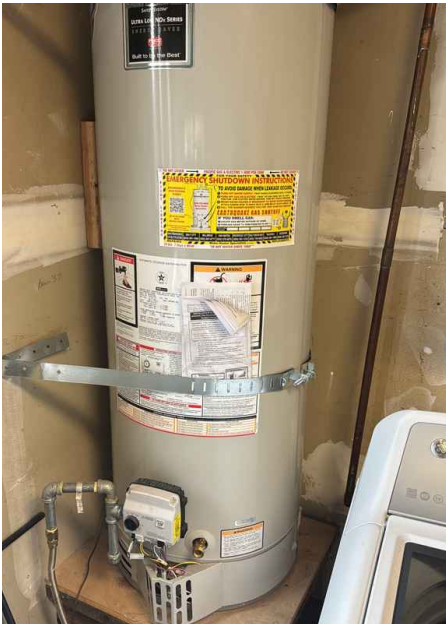
## Hot Water Source: Inspected Hot Water Source

I inspected the hot water source and equipment according to the [Home Inspection Standards of Practice](#).

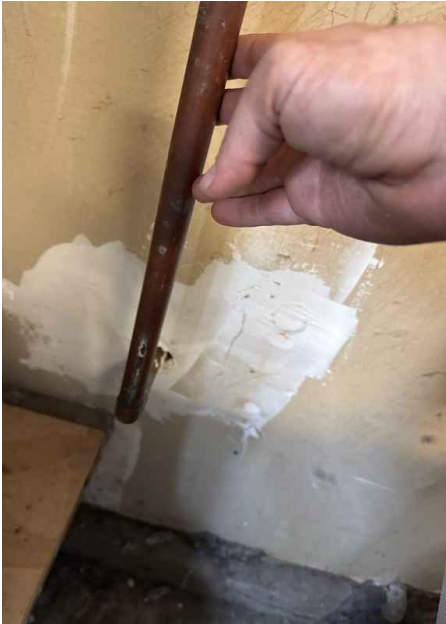
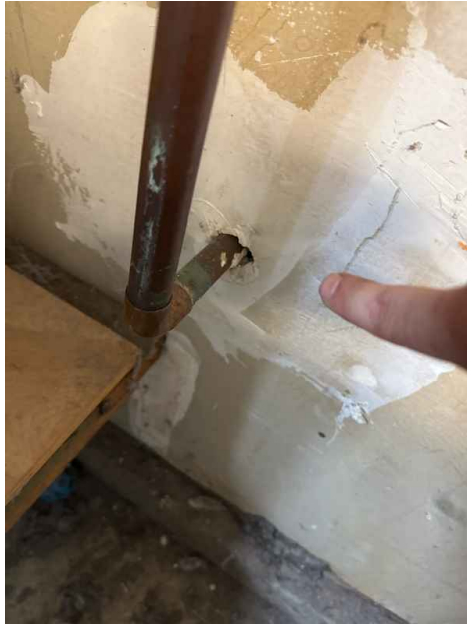
**Hot Water Source: Inspected TPR Valve**

I inspected the temperature and pressure relief valve.

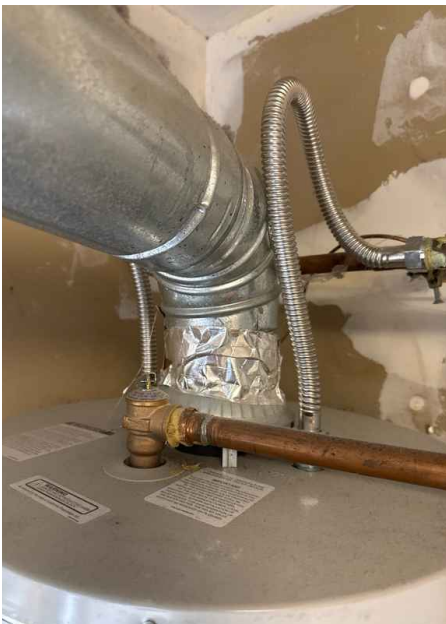
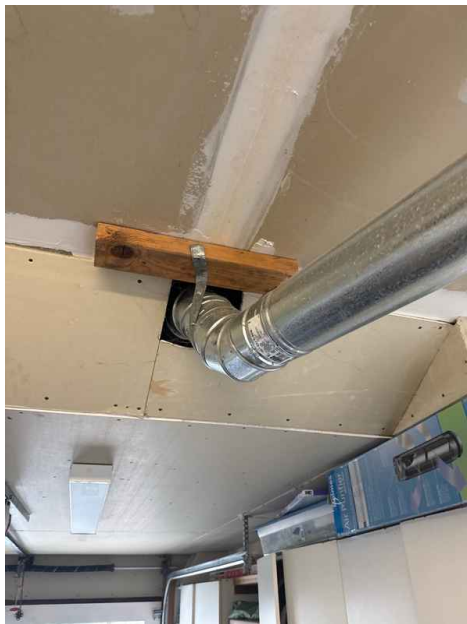
**Hot Water Source: Inspected Venting Connections**

I inspected the venting connections.

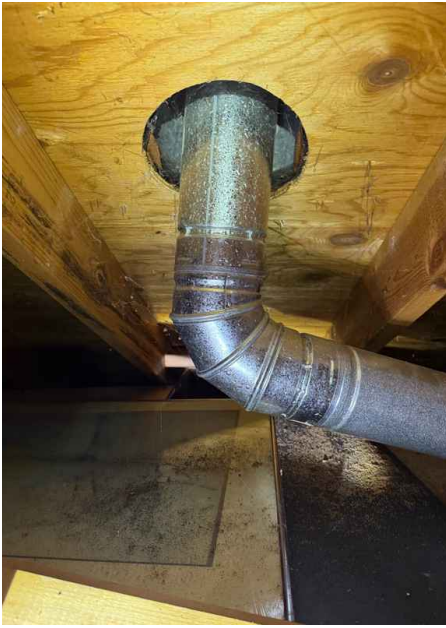
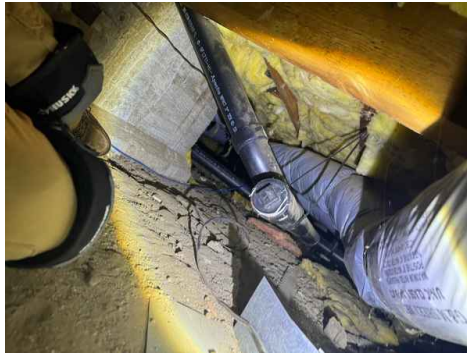
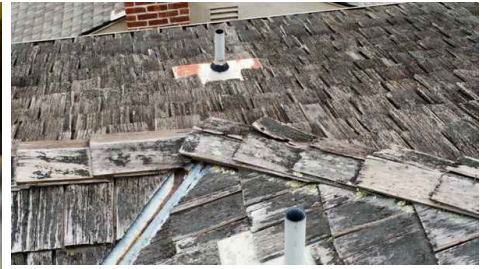
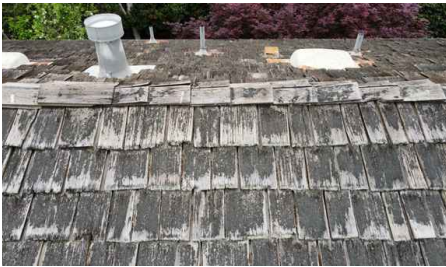
**Drain, Waste, & Vent Systems: Inspected Drain, Waste, Vent Pipes**

I attempted to inspect the drain, waste, and vent pipes. Not all of the pipes and components were accessible and observed. Inspection restriction. Ask the homeowner about water and sewer leaks or blockages in the past.

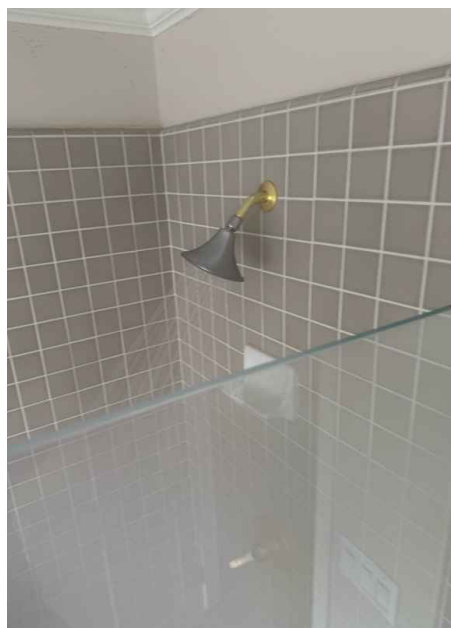
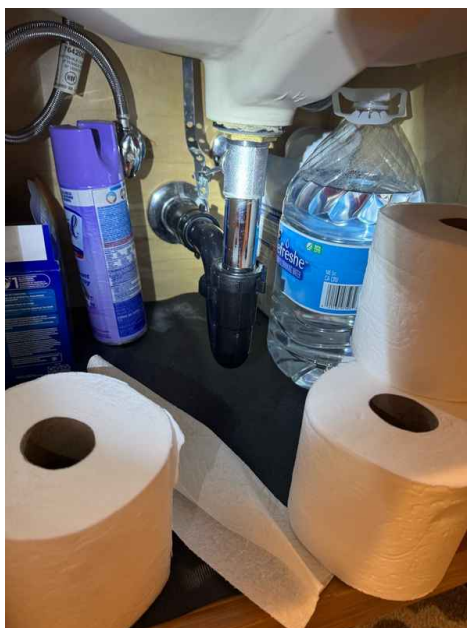
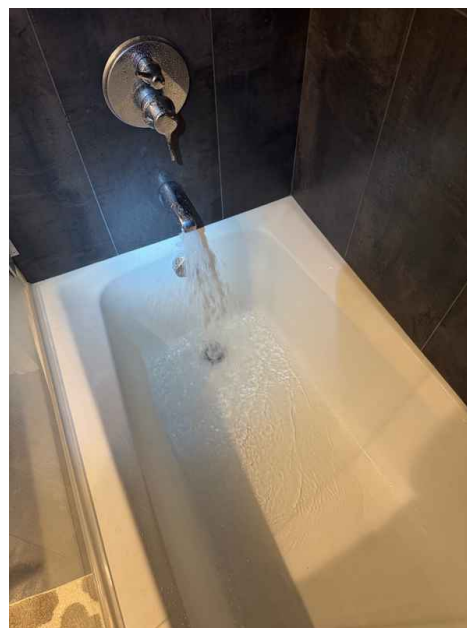
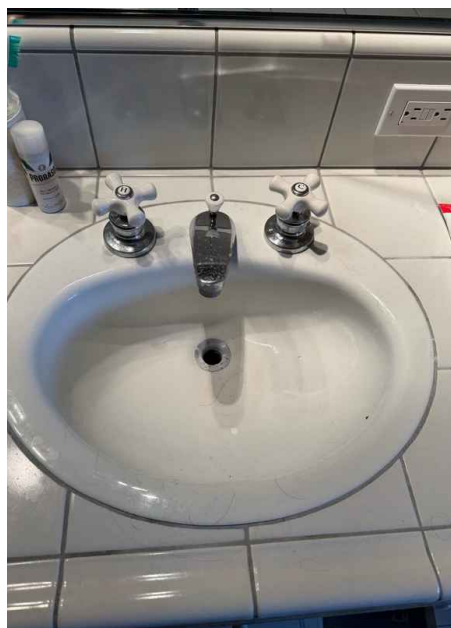
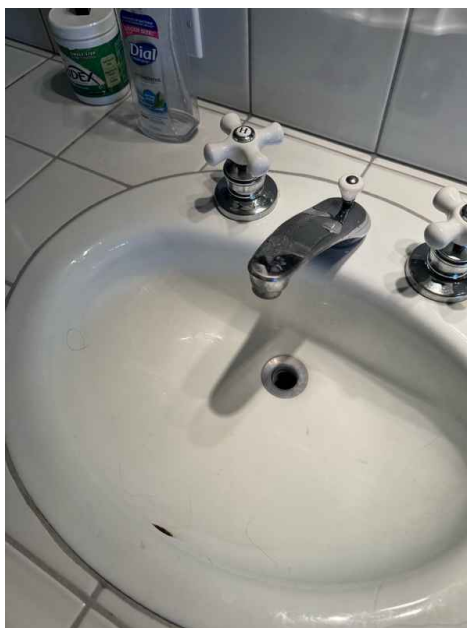
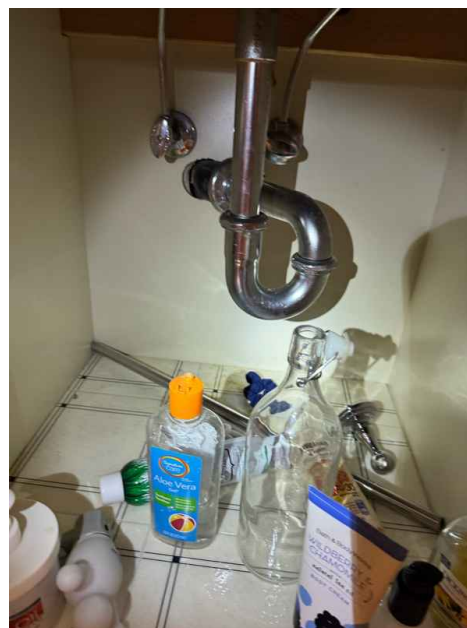
**Water Supply & Distribution Systems: Inspected Water Supply & Distribution Pipes**

I attempted to inspect the water supply and distribution pipes (plumbing pipes). Not all of the pipes and components were accessible and observed. Inspection restriction. Ask the homeowner about water supply, problems with water supply, and water leaks in the past.

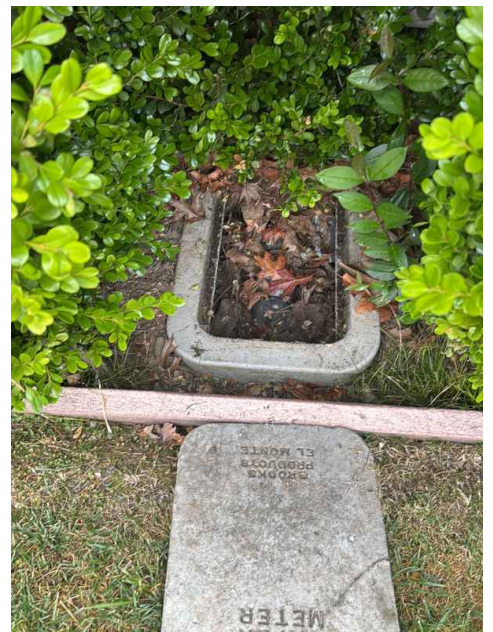
Main Water Shut-Off Valve

### **INACCESSIBLE**

I observed conditions that made the inspection of the main water shut-off valve inaccessible. Inspection restriction.

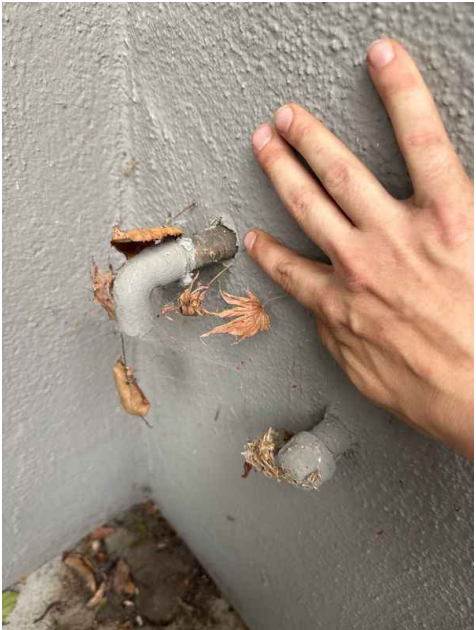
DEFECT AT THE TPR VALVE

Major Defect

I observed a defect a the TPR (temperature, pressure, and relief) valve. The discharge pipe that serves a temperature pressure relief valve must:

- Not be connected to the drainage system.
- Discharge through an air gap located in the same room as the water heater.
- Not be smaller than the diameter of the outlet of the valve.
- Serve a single relief device.
- Discharge to the floor.
- Discharge in a manner that does not cause personal injury or structural damage.
- Discharge to a termination point that is readily observable.
- Not be trapped.
- Be installed so as to flow by gravity.
- Terminate no more than 6 inches above the floor or flood level rim of the waste receptor. And not less than 2 times the discharge pipe diameter.
- Not have valves or tee fittings.
- Be constructed of materials listed or rated for such use.
- Be one nominal size larger that the size of the relief valve outlet, where the relief valve discharge piping is installed with insert fittings.
