HI-FI HOME INSPECTIONS L.L.C

## BEN GROMICKO'S TEMPLATE FOR HOME INSPECTIONS

1234 Main Street  
Palo Alto, CA 94301

Buyer Name  
08/25/2025 9:00AM

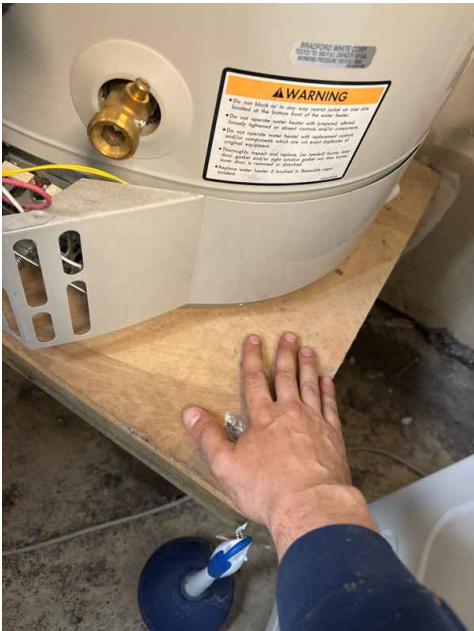
MISSING CATCH PAN UNDER TANK

Minor Defect

I observed that the hot water tank is missing a water leak catch pan.

Recommendation  
Contact a qualified professional.

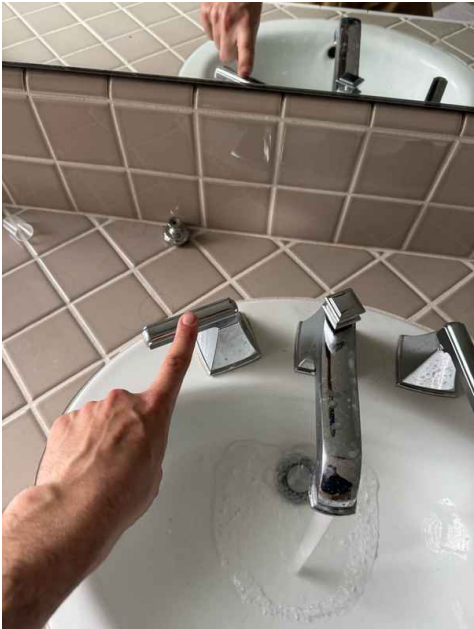
7.5.1 Water Supply & Distribution Systems

DEFICIENCY IN THE HOT & COLD WATER SUPPLY

I observed indications of a defect in the hot and cold water supply.

Recommendation  
Contact a qualified plumbing contractor.

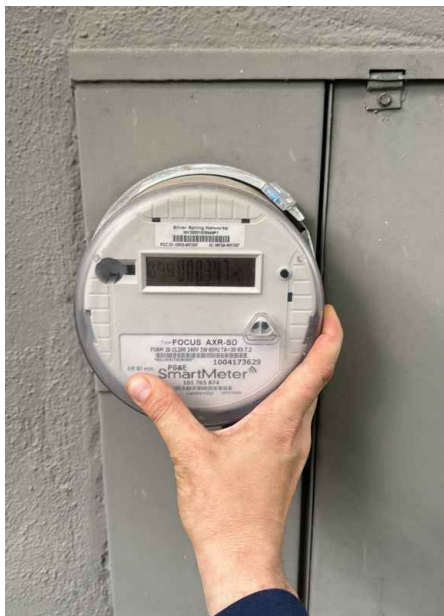
#### Electric Meter & Base: Inspected the Electric Meter & Base

I inspected the electrical electric meter and base.

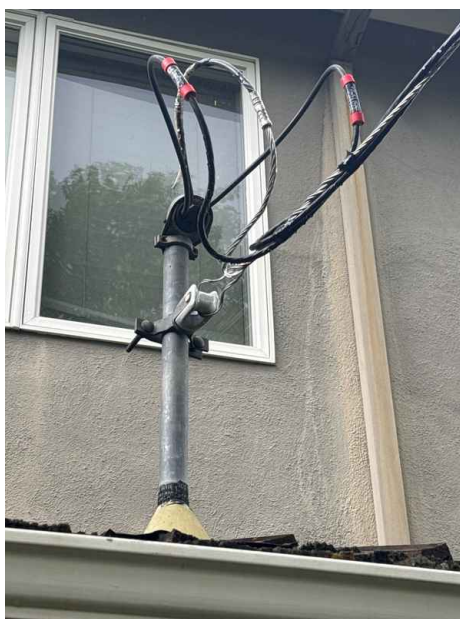
#### Service-Entrance Conductors: Inspected Service-Entrance Conductors

I inspected the electrical service-entrance conductors.

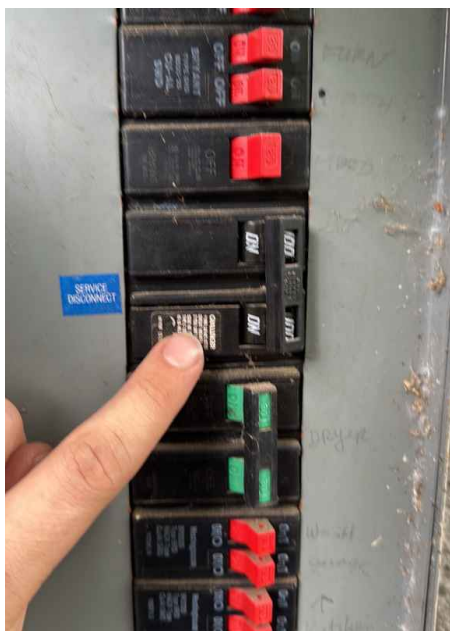
100

I observed indications of the main service disconnect's amperage rating. It was labeled.

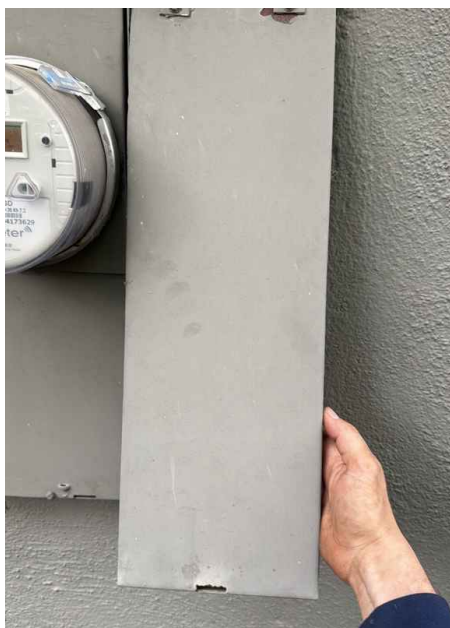
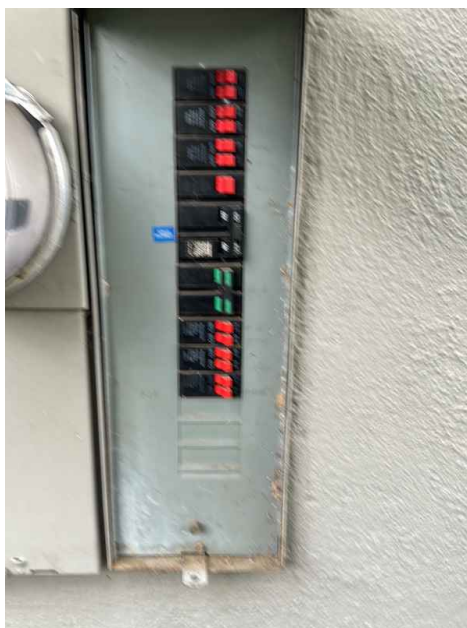
**Panelboards & Breakers: Inspected Main Panelboard & Breakers**

I inspected the electrical panelboards and over-current protection devices (circuit breakers and fuses).

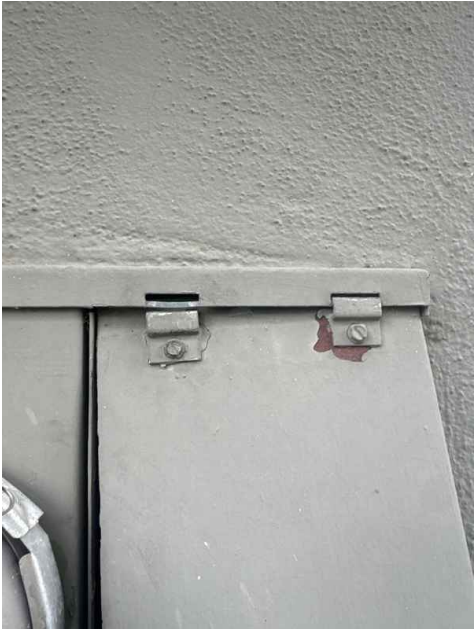
**DAMAGE TO PANEL COVER**

I observed damage and a defect at the electrical panel cover.

Contact a qualified professional.

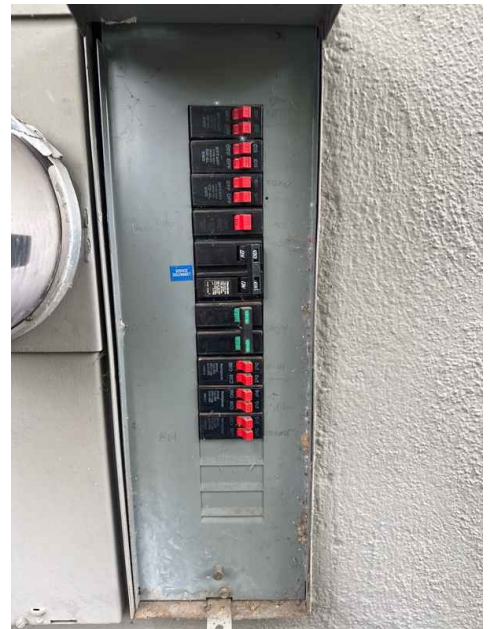
8.5.3 Panelboards & Breakers

**ZINSCO PANEL**

I observed indications that the panelboard was manufactured by Zinsco. These panels have a reputation for being problematic and further evaluation by a qualified electrician is recommended. Zinsco panels can generally be identified by a blue and silver "Zinsco" label inside the panel, an embossed "Magnetrip" label at the top of the panel face, and the colorful breakers.

- There may be components of the panel that contain aluminum.
- The connection between the breakers and the bus bar may be defective.
- The bus bar may be corroded.
- Breakers may be turned off, but the circuit could still be live.

The obsolete and unreliable Zinsco panel should be further evaluated and replaced by a licensed electrician.

Contact a qualified electrical contractor.

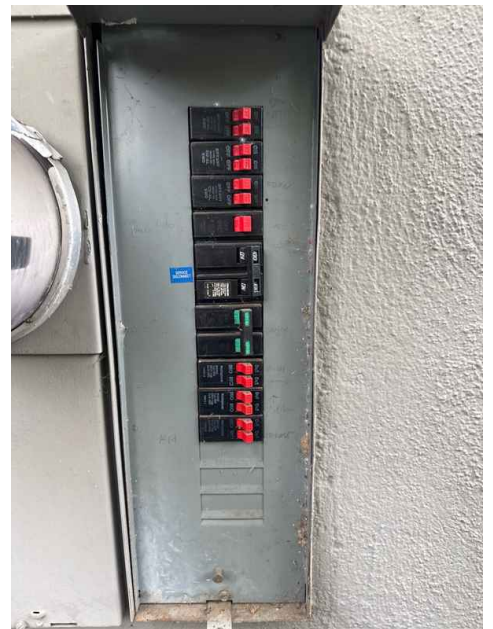
#### 8.7.1 AFCIs

### MISSING AFCI

I observed indications that an AFCI is missing in an area that is required to keep the house safe.

Contact a qualified electrical contractor.

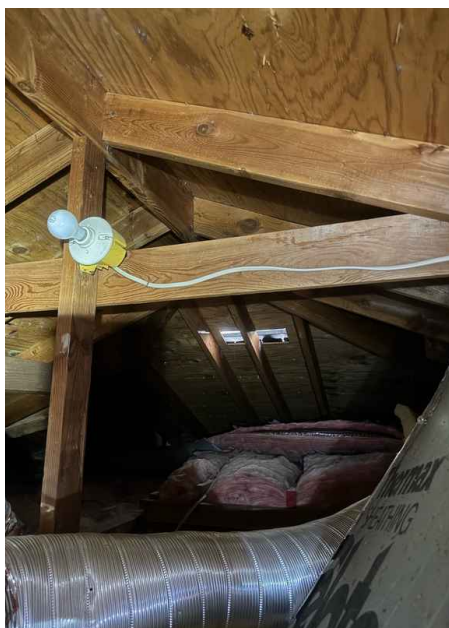
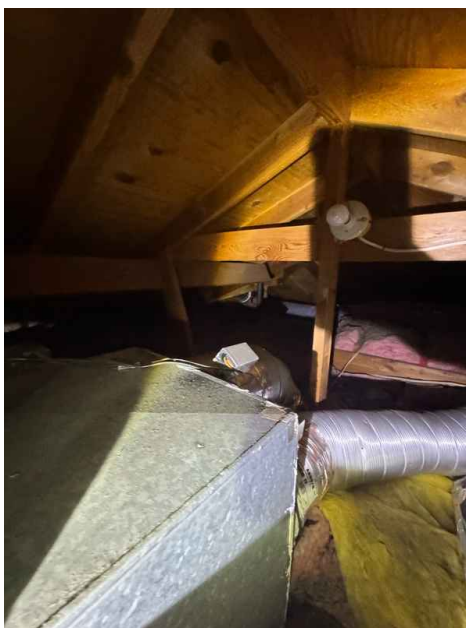
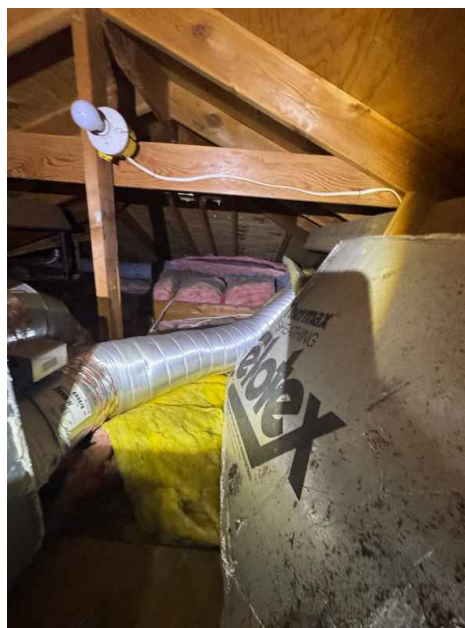
#### Structural Components & Observations in Attic: Structural Components Were Inspected

Structural components were inspected from the attic space according to the [Home Inspection Standards of Practice](#).

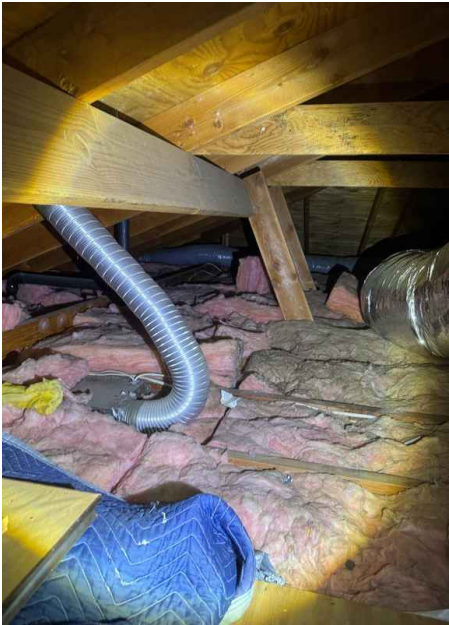
Insulation in Attic: Insulation Was Inspected

6-9 inches

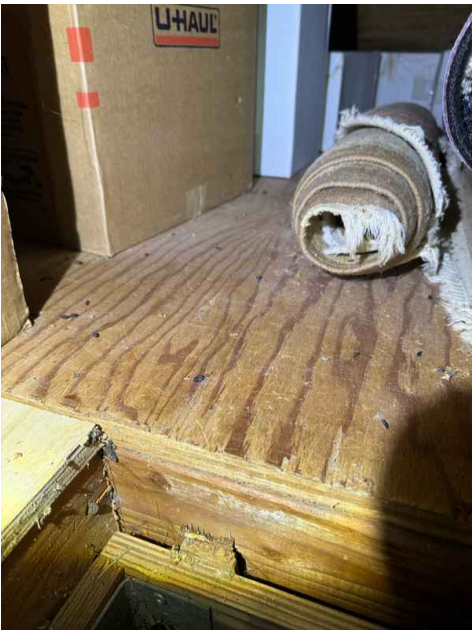
9.1.2 Structural Components & Observations in Attic

**EVIDENCE OF RODENTS**

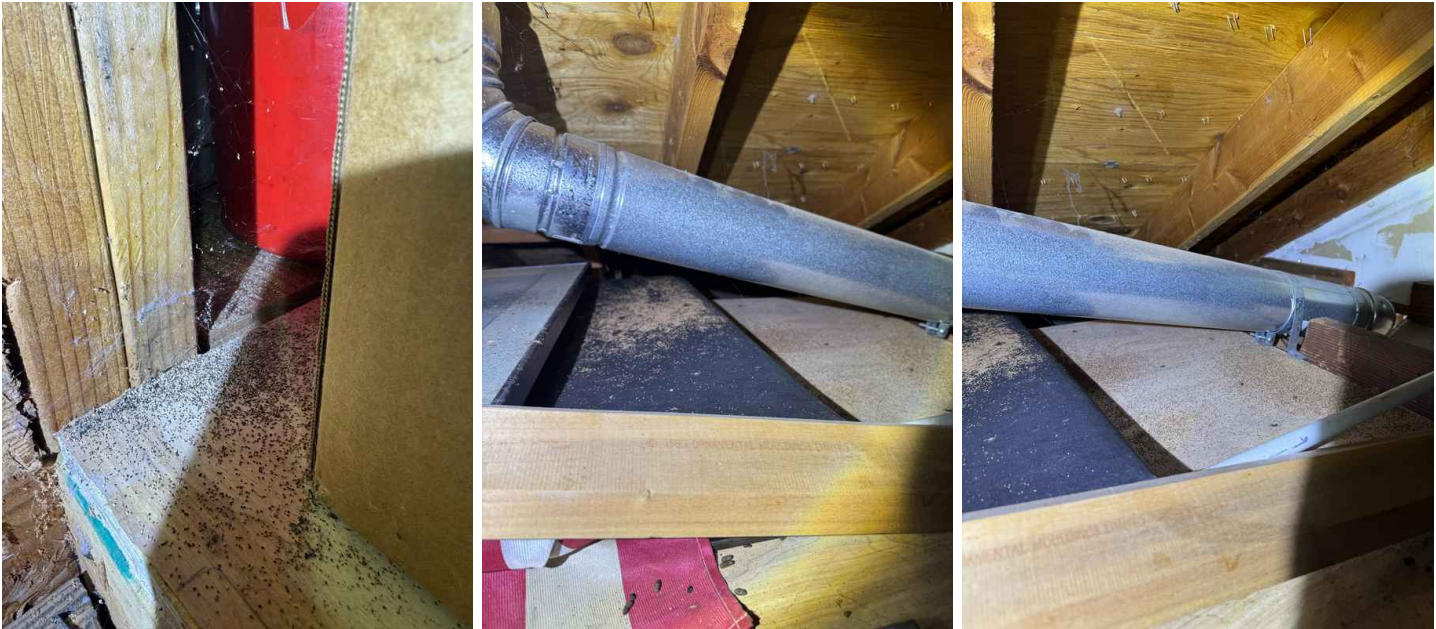
9.1.3 Structural Components & Observations in Attic

**EVIDENCE OF TERMITES**

There was evidence of termite damage during the inspection.

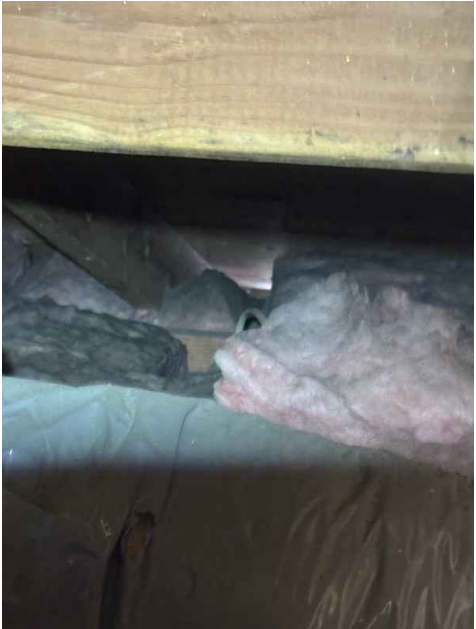
9.3.1 Ventilation in Attic

**SOFFIT VENT COVERED**

Major Defect

There were soffit vents covered with insulation at the time of the inspection

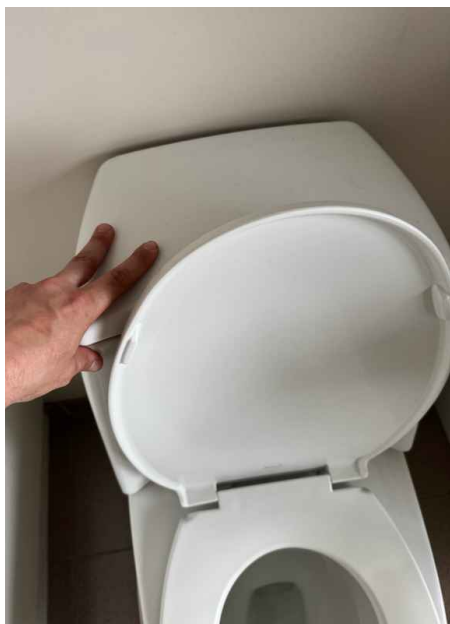
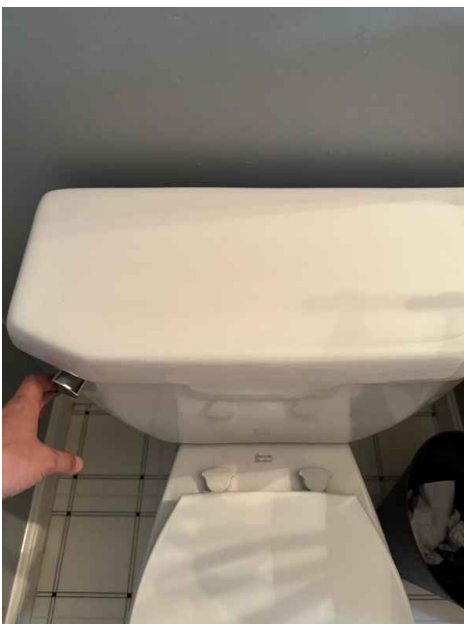
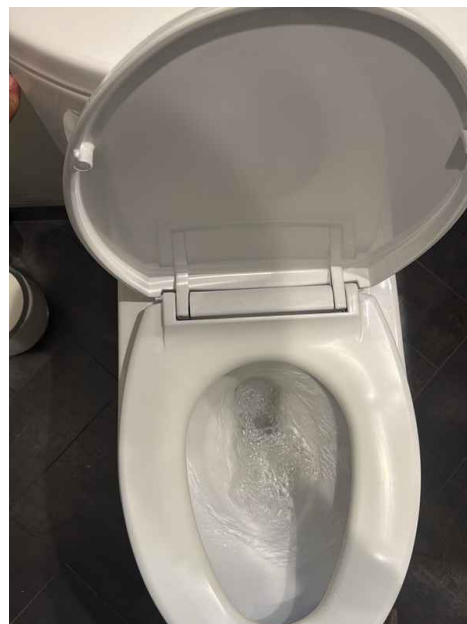
#### Bathroom Toilets: Toilets Inspected

I flushed all of the toilets.

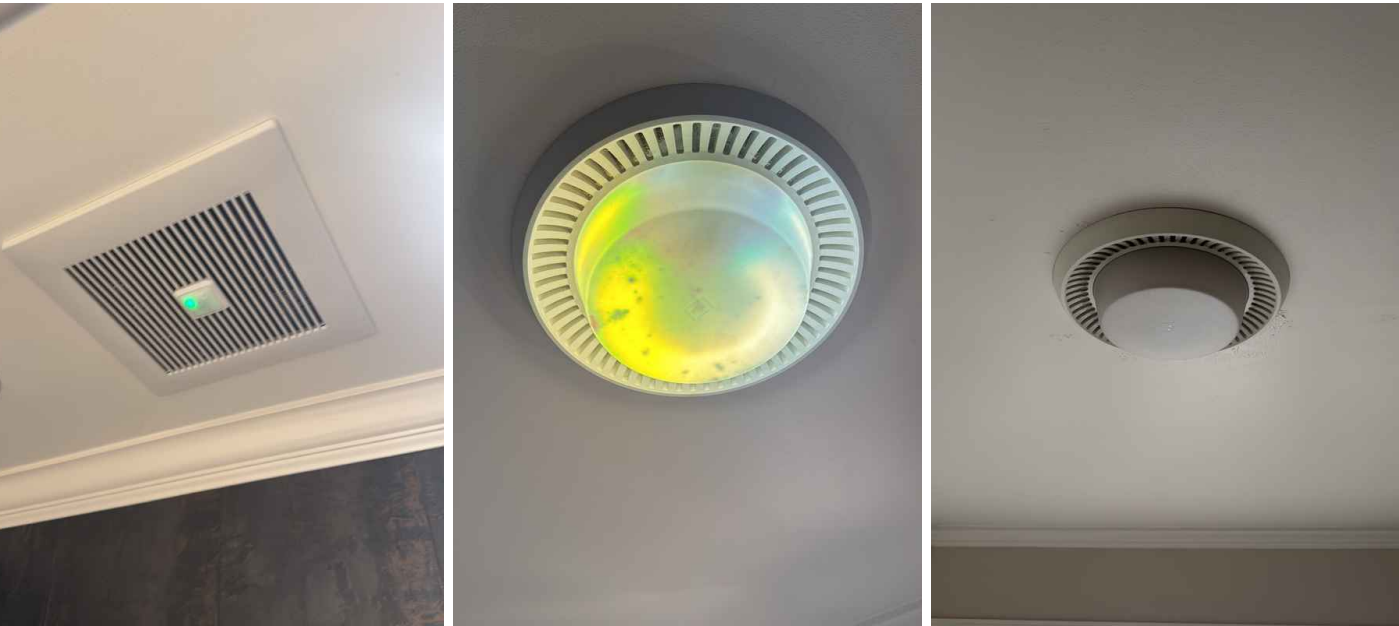
Bathroom Exhaust Fan / Window: Inspected Bath Exhaust Fans

I inspected the exhaust fans of the bathroom(s). All mechanical exhaust fans should terminate outside. Confirming that the fan exhausts outside is beyond the scope of a home inspection.

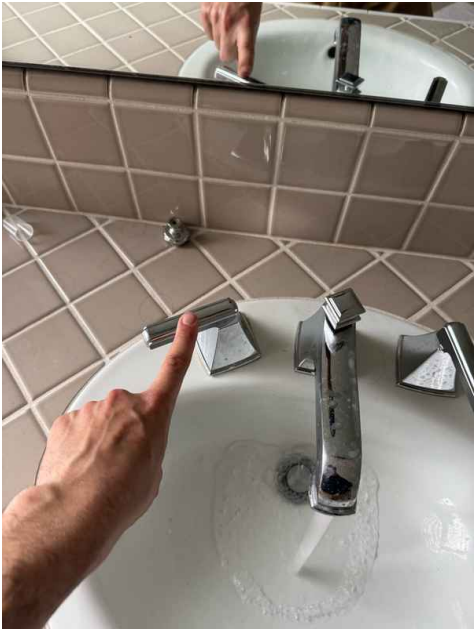
I observed damage at the fixture.

Recommendation  
Contact a qualified plumbing contractor.

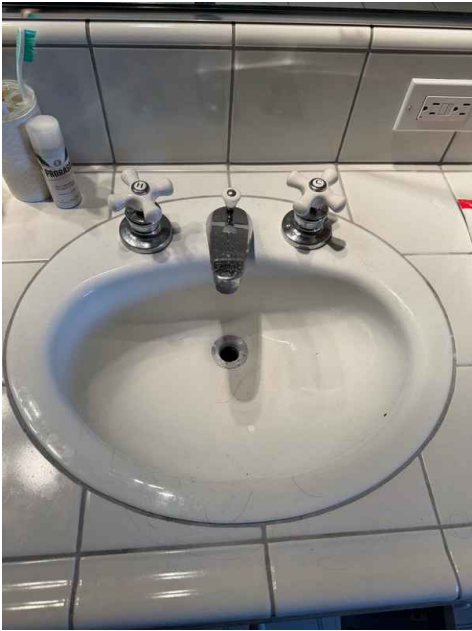
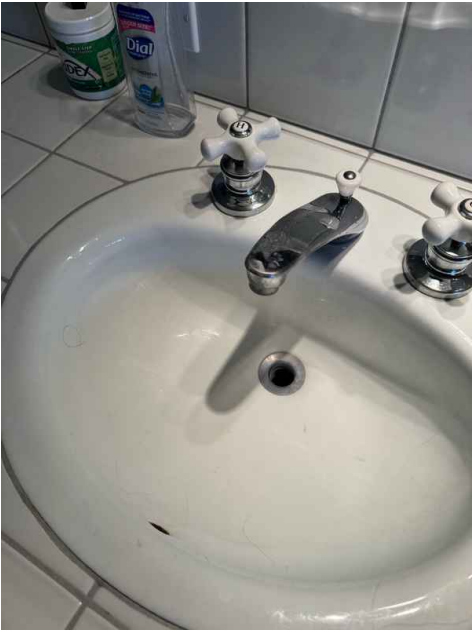
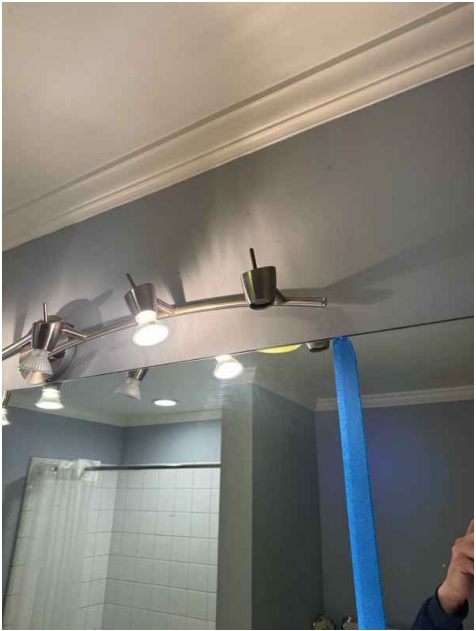
10.2.2 Sinks, Tubs & Showers  
**MISSING COMPONENT AT FIXTURE**

I observed a missing component at the fixture.

Recommendation  
Contact a qualified plumbing contractor.

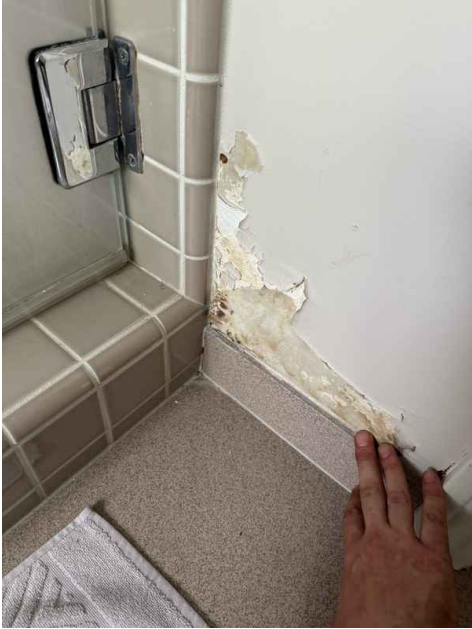
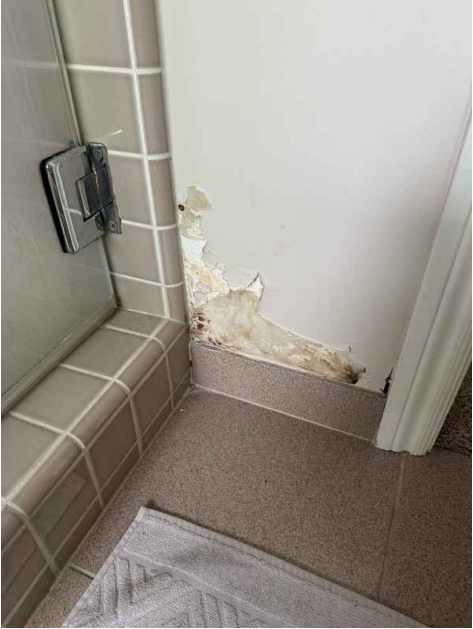
10.6.1 Cabinetry, Ceiling, Walls & Floor

**WALL DAMAGE**

I observed damage at the bathroom wall.

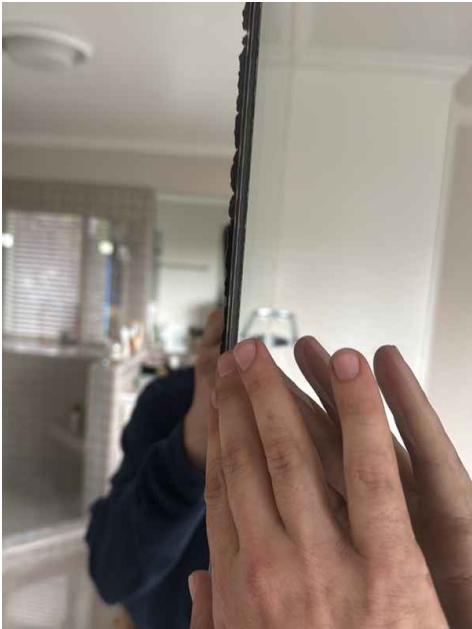
10.6.2 Cabinetry, Ceiling, Walls & Floor

**MIRROR DEFECT**

I observed indications of a defect at the mirror in the bathroom.

Recommended DIY Project

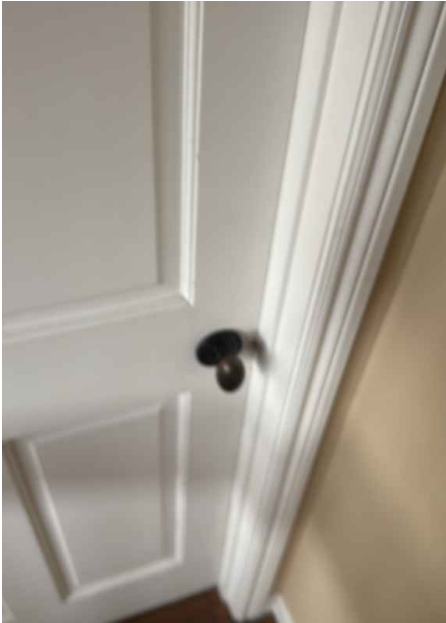
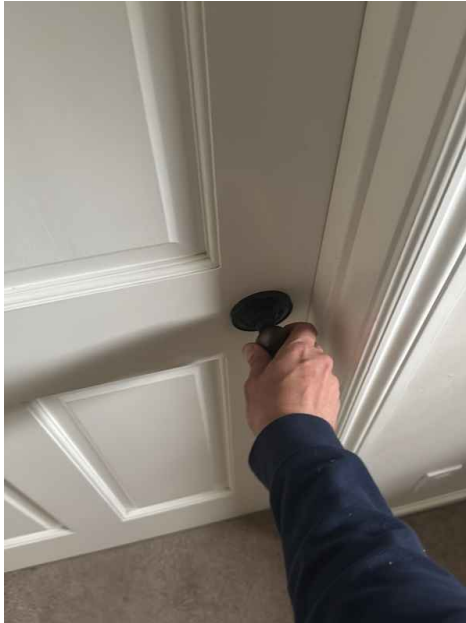
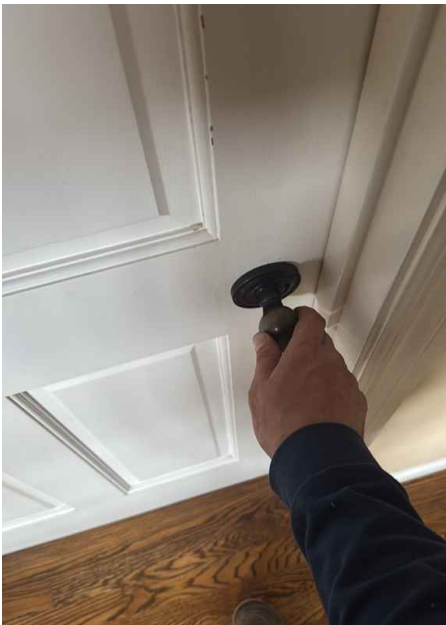
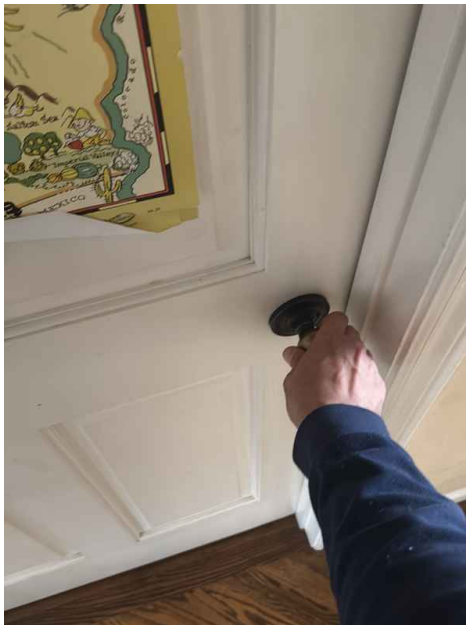
**Doors: Doors Inspected**

I inspected a representative number of doors according to the [Home Inspection Standards of Practice](#) by opening and closing them. I did not operate door locks and door stops, which is beyond the scope of a home inspection.

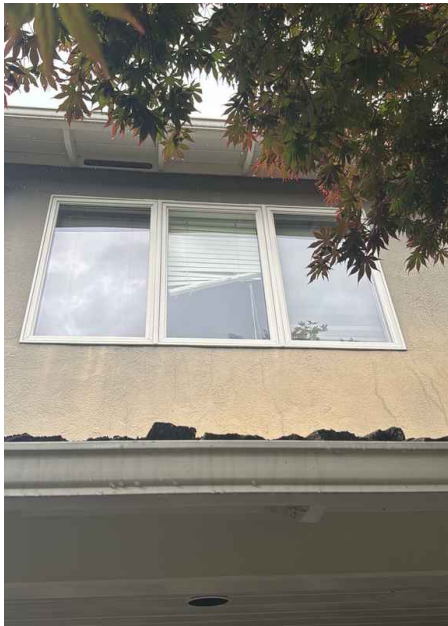
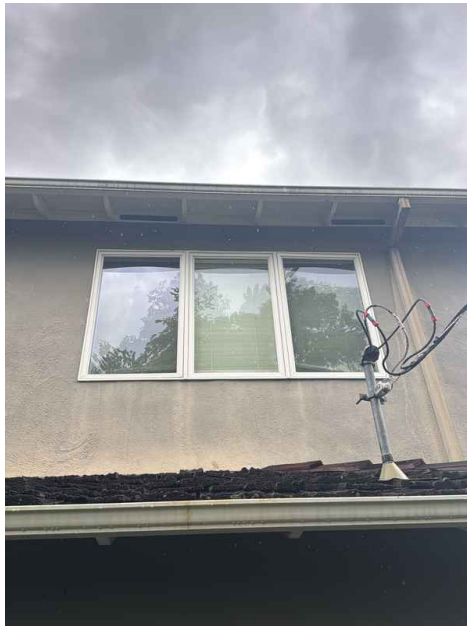
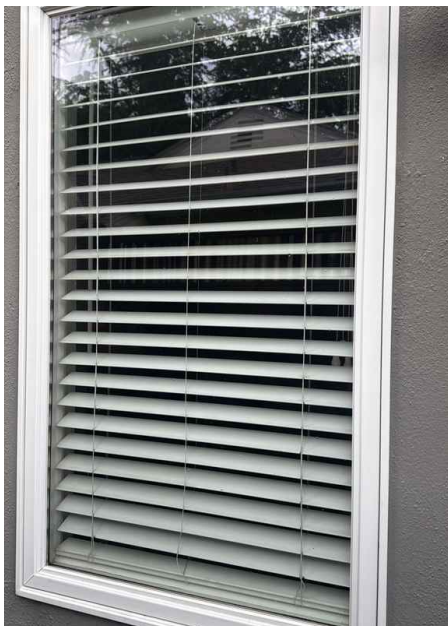
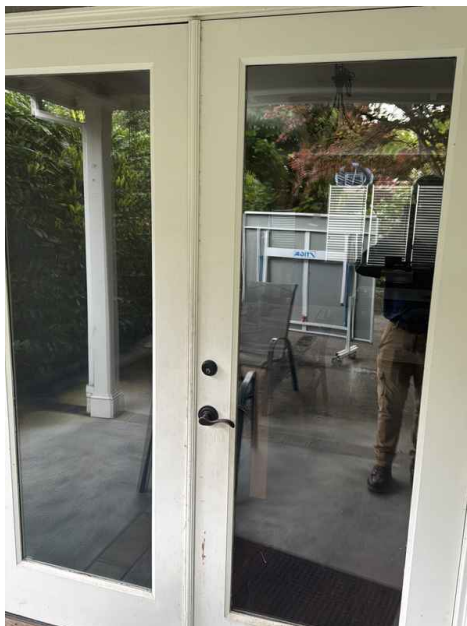
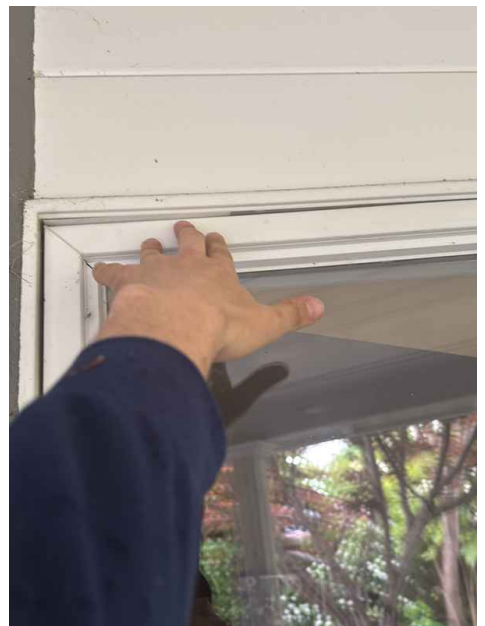
**Windows: Windows Inspected**

I inspected a representative number of windows according to the [Home Inspection Standards of Practice](#) by opening and closing them. I did not operate window locks and operation features, which is beyond the scope of a home inspection.

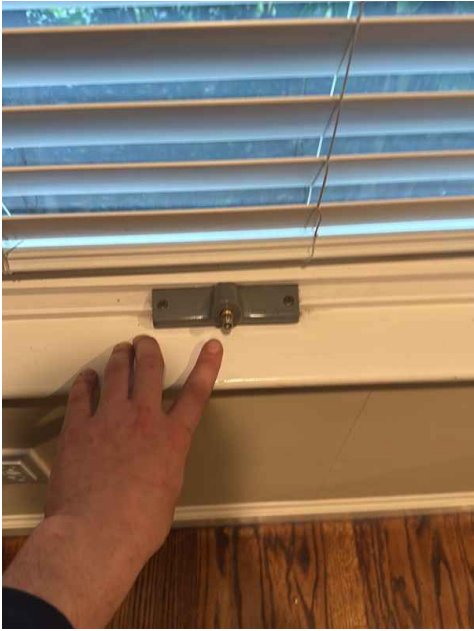
DAMAGED HARDWARE AT WINDOW

I observed damage to the hardware at a window.

Recommendation

Contact a qualified window repair/installation contractor.

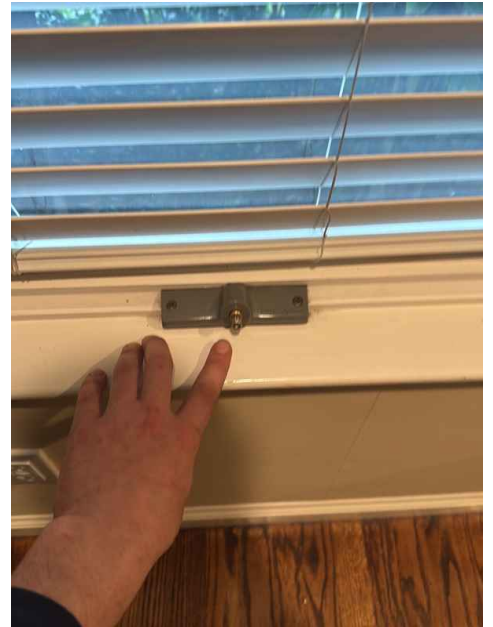
11.2.2 Windows

MISSING HARDWARE AT WINDOW

I observed missing hardware at a window.

## Recommendation

Contact a qualified window repair/installation contractor.

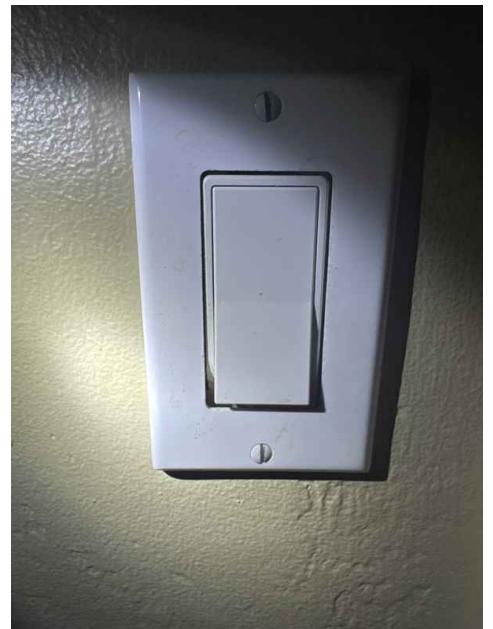
## 11.3.1 Switches, Fixtures &amp; Receptacles

**DAMAGED ELECTRICAL COMPONENT**

I observed damage to an electrical component. Electrical hazard.

## Recommendation

Contact a qualified electrical contractor.

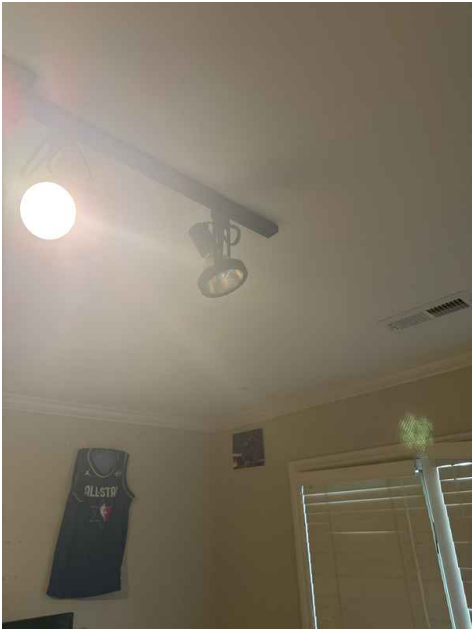
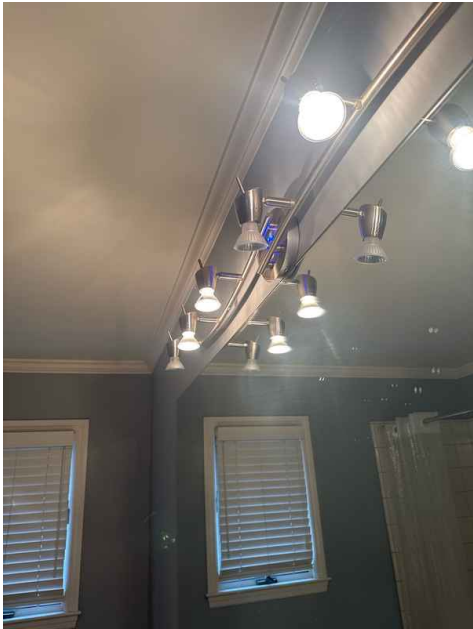
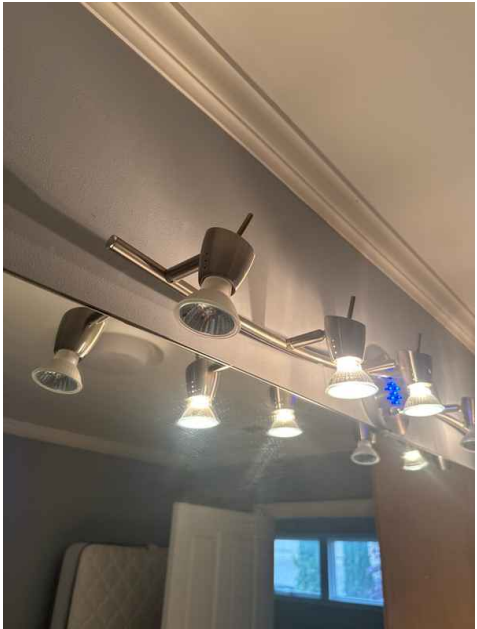
## 11.3.2 Switches, Fixtures &amp; Receptacles

**LIGHT INOPERABLE, COULD BE BULB**

I observed one or more lights that were not turning on. A new light bulb was possibly needed. We recommend asking the homeowner about why this light fixture did not turn on.

## Recommendation

Contact a qualified electrical contractor.

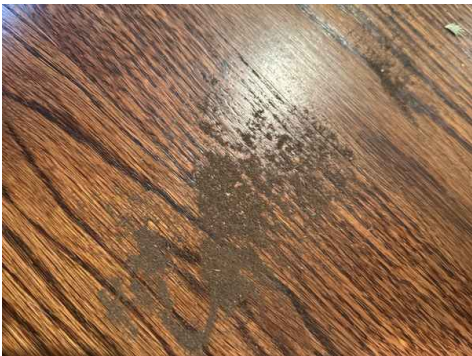
11.4.1 Floors, Walls, Ceilings

DAMAGED FLOORING

There was damaged flooring in the living room at the time of the inspection. It appears to be from termites further evaluation by a pest management company is recommended.

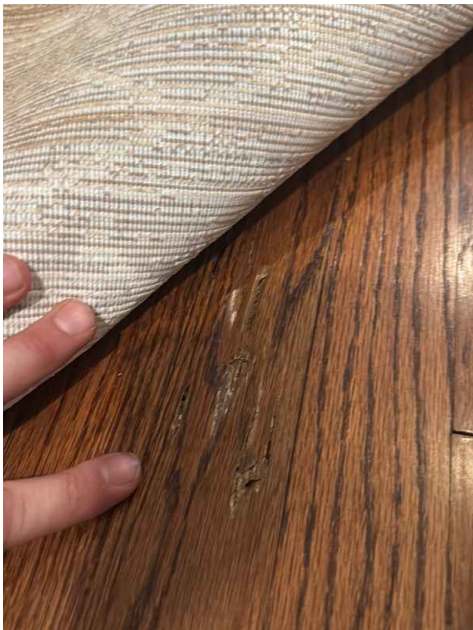
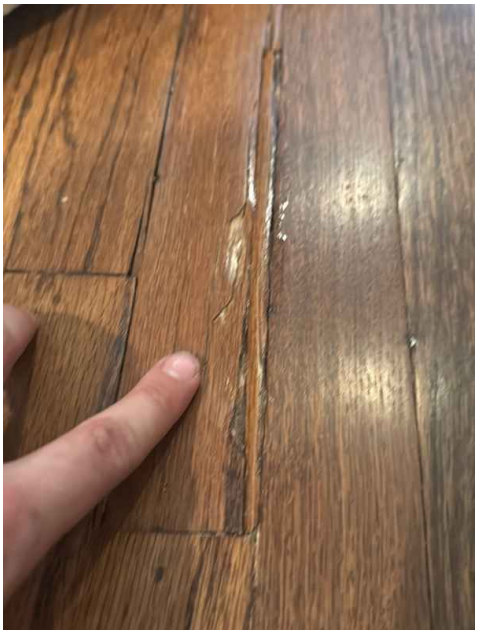
Major Defect

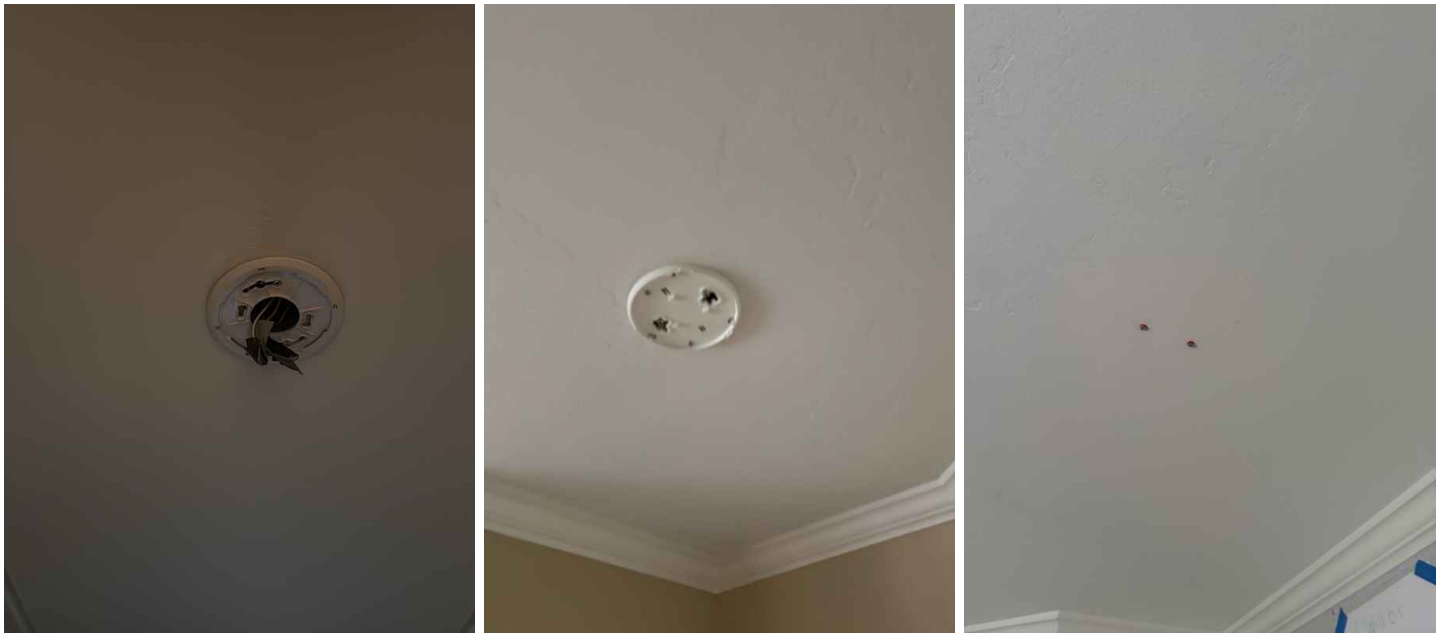
**MISSING SMOKE DETECTOR**

I observed indications of a missing smoke detector. Hazard.

Recommendation

Contact a qualified professional.

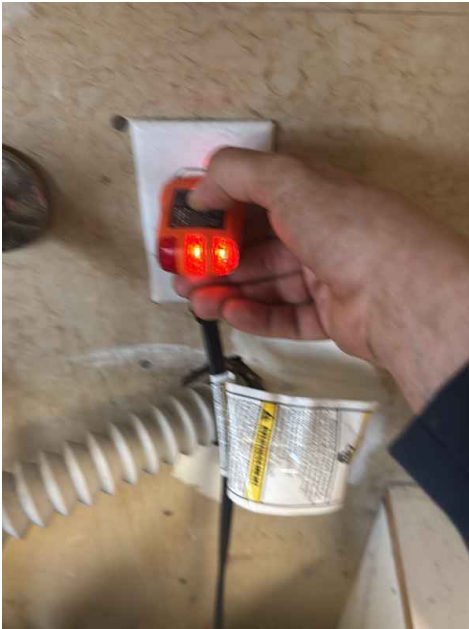
### MISSING GFCI PROTECTION IN LAUNDRY

I observed missing GFCI protection for all receptacle outlets in the laundry, as it is required by standards.

Recommendation

Contact a qualified electrical contractor.

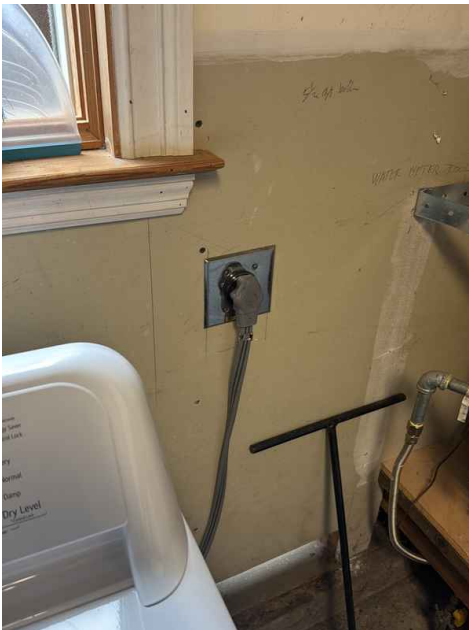
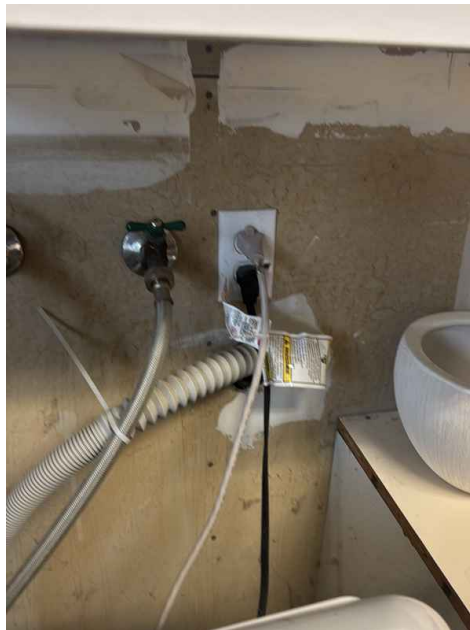
### 12.3.1 Laundry Room, Electric, and Tub

#### **MISSING AFCI PROTECTION**

I observed that there is missing AFCI protection at the receptacles in the laundry room.

#### Recommendation

Contact a qualified electrical contractor.

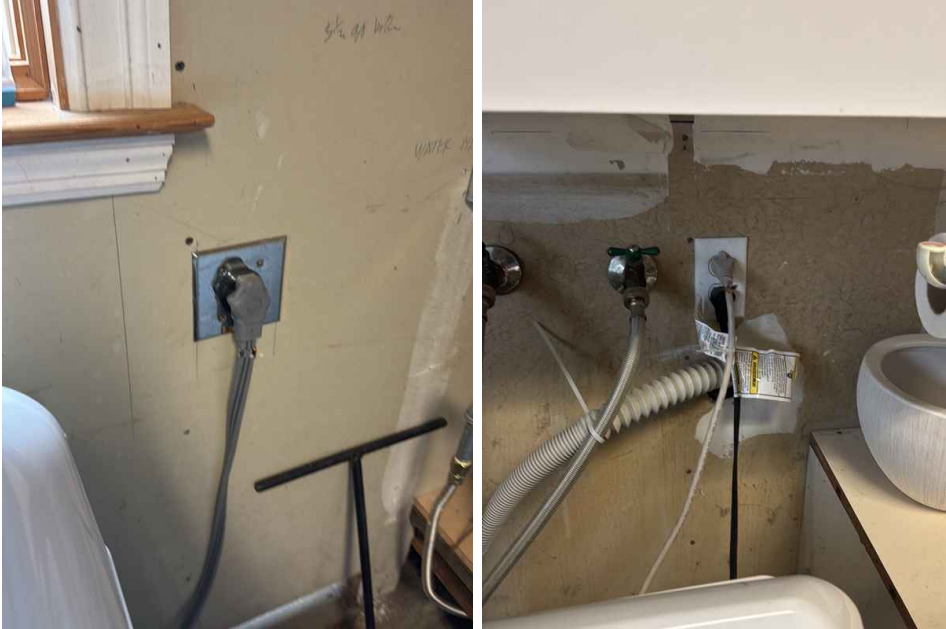
### 12.3.2 Laundry Room, Electric, and Tub

#### **MISSING GFCI PROTECTION**

I observed that there is missing GFCI protection at the receptacles in the laundry room.

#### Recommendation

Contact a qualified electrical contractor.

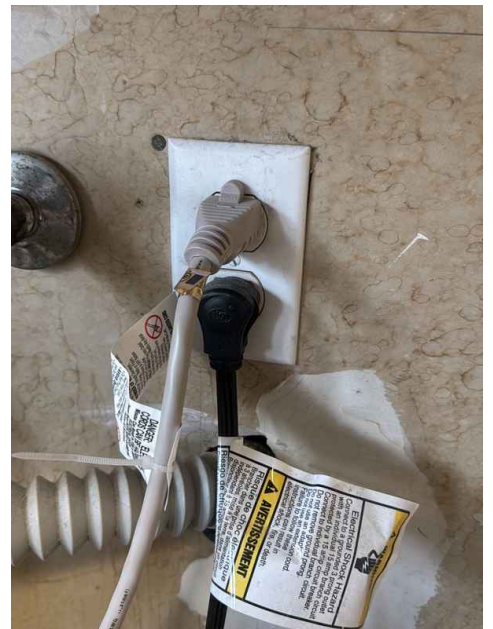
#### 12.3.3 Laundry Room, Electric, and Tub

##### **MISSING TAMPER RESISTANT RECEPTACLE TYPE**

I observed receptacles in the laundry room that are not TR (tamper resistant) type.

#### Recommendation

Contact a qualified electrical contractor.

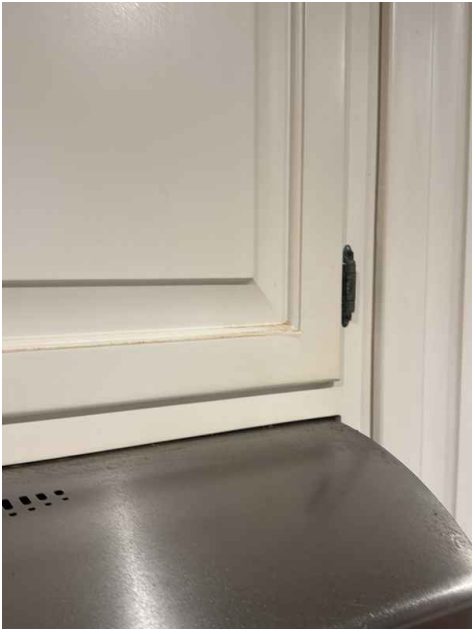
13.4.1 Countertops & Cabinets

**WORN AREAS AT CABINETS**

I observed worn areas and some damage at the cabinets.

Recommendation

Recommend monitoring.

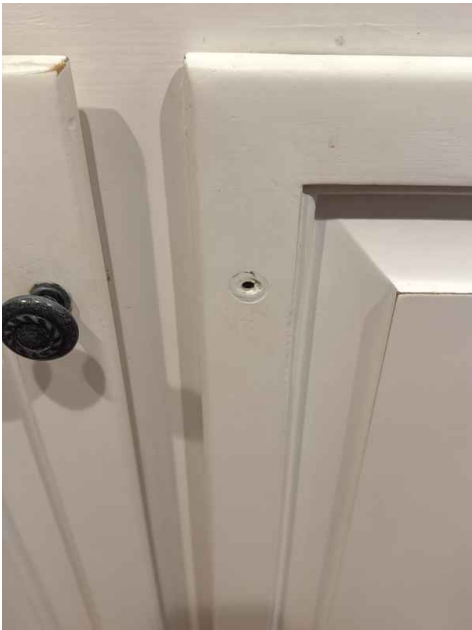
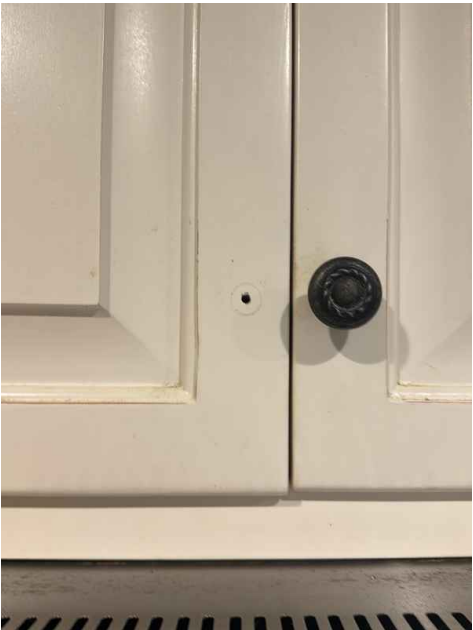
13.4.2 Countertops & Cabinets

**CABINET HANDLE MISSING/LOOSE**

I observed a missing/loose cabinet handle.

Recommendation

Recommended DIY Project
